Home Performance Report

115 E. Ogden
Naperville IL

Insight Property Services, Inc

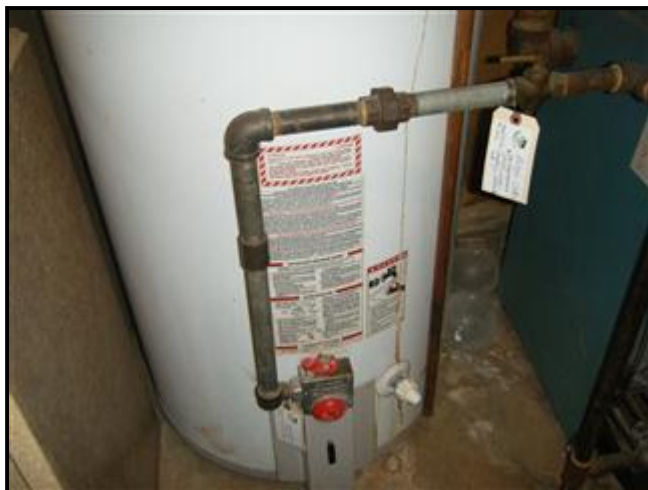
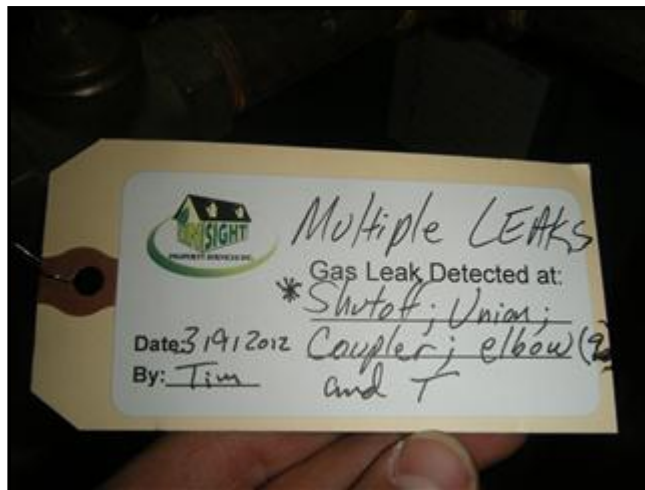
- Multiple gas leaks were detected near the water heater. A qualified individual should repair and re-test the gas leaks as soon as possible.

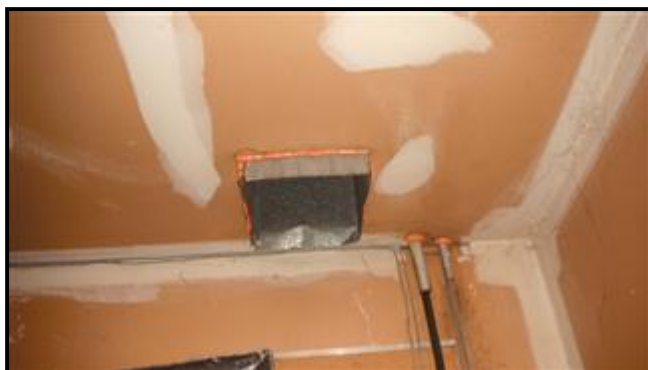
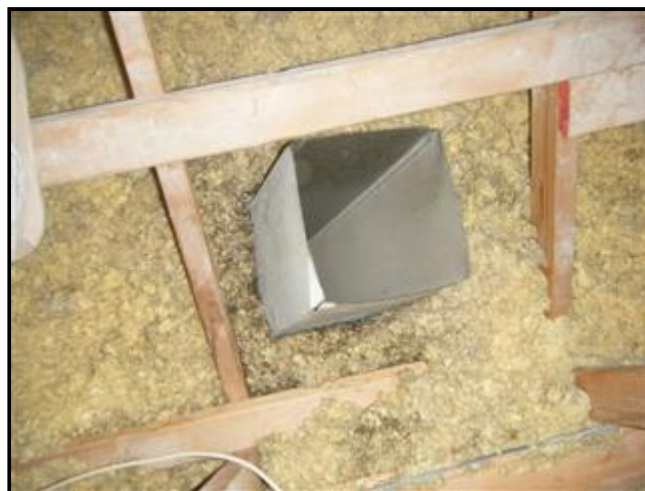
- The open duct in the ceiling provides makeup air for the boiler and water heater. Recommend this duct be maintained clear and consult a qualified HVAC contractor with any issues.

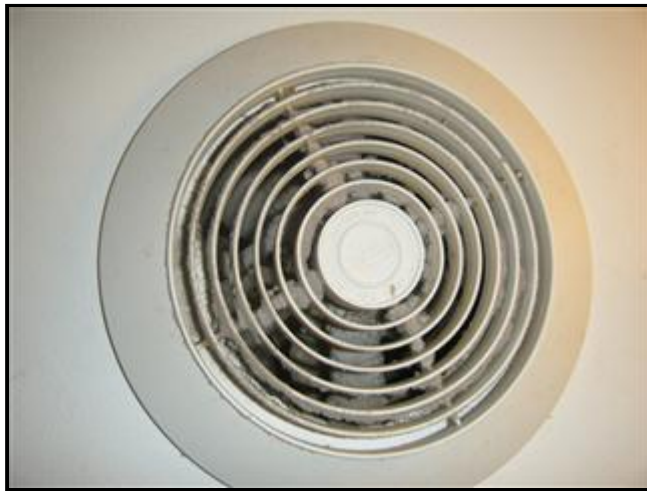
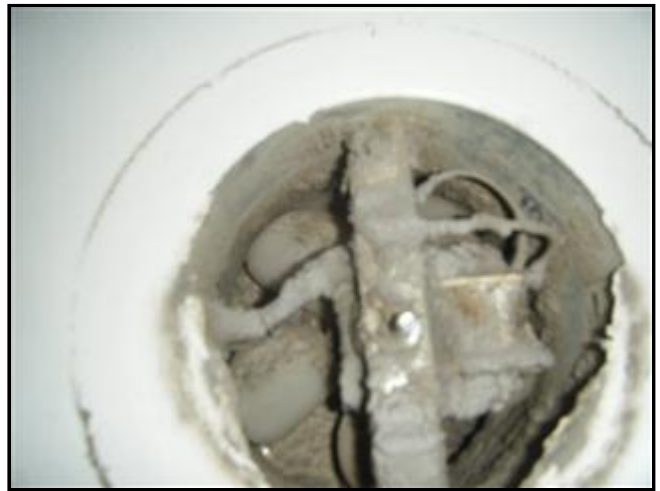
(1) There are NO bath fan exhaust ducts through the walls or into the attic. It is likely that the bath fans are exhausting into the wall cavities. These wall cavities, in turn, are open to the attic and the likely source of the moisture in the attic.

Recommend new bath fans be installed in each bathroom, ducted up through the attic and out through dampered vents in the gable wall.

Each fan should be quiet (<1.5 sones) and have 80+cfm exhaust capacity. Suggest the fans be wired to the lights so they are used whenever someone uses the tub or shower. Fans with low continuous operation should be installed to provide fresh air exchange for each unit and the negative pressure generated in the unit would keep odors from drifting out into the halls.

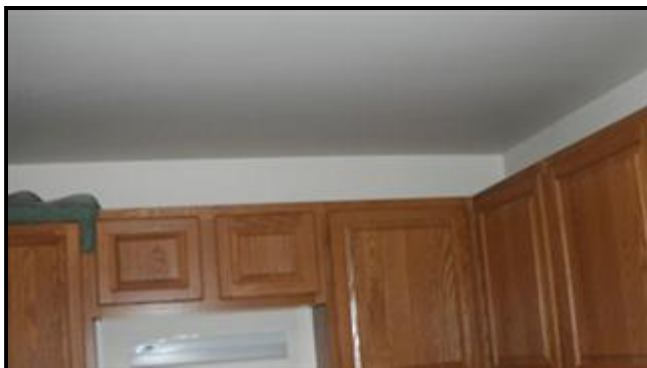
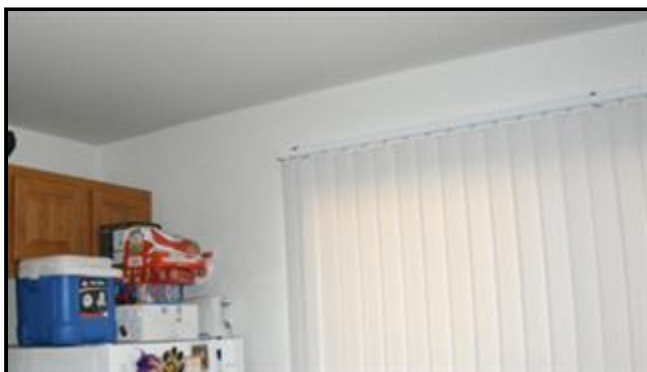
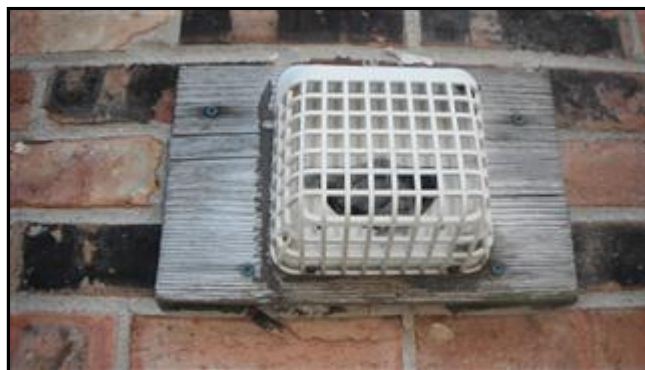
(2) Air flow was identified in the ceilings of the lower units following the dryer vent and other penetrations to the outside. These openings should be sealed well and the dampered vents replaced as needed so they seal when closed.

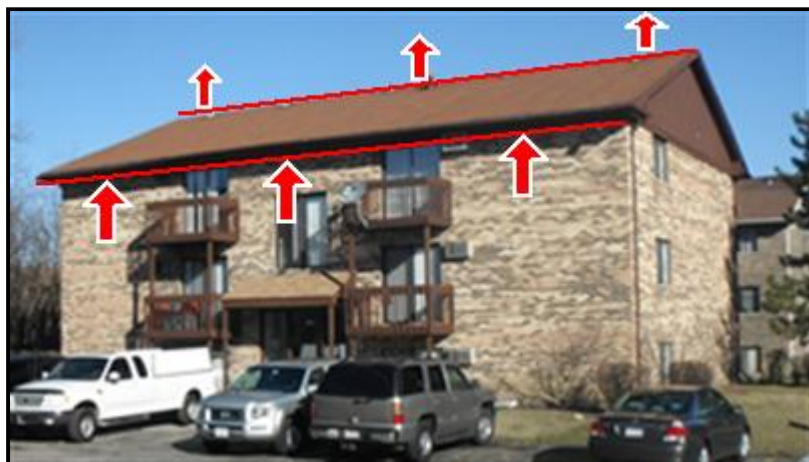
2.4 Picture 1

The soffit vents are too few. 2 ft² (288 in²) of "Net-Free" soffit vent opening is required along each of the soffits for a total of 4 ft² of intake capacity for the attic. [Air Vent](#) has 16"x6" under-eave vents with 42 in² of net-free opening each. 7 of these would be needed along each side - total of 14.

The top of the roof should also have 4 ft² of net-free exhaust opening. The existing (5) roof vents have ~140 in², about 25% of the necessary 576 in². [Air Vent's ShingleVent II](#) provides 18 in² net-free per foot while deflecting driving wind, rain and snow. The existing roof vents may remain and can be eliminated when the shingles are next replaced.

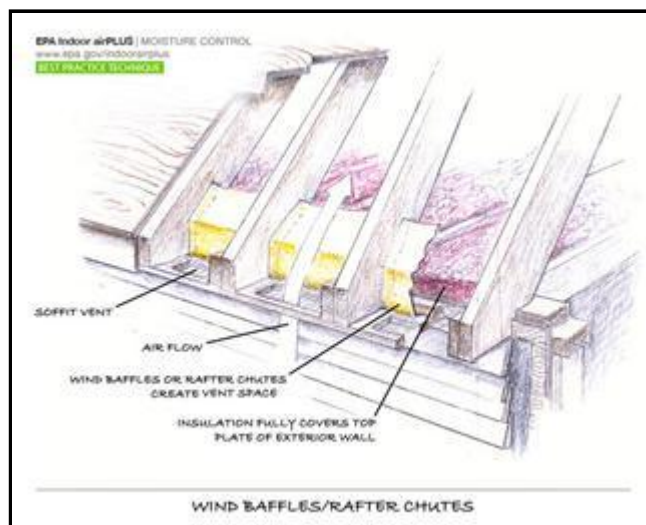
2.4 Picture 3

(2) The attic currently does not contain wind baffles and only a few vent chutes. Recommend installing vent chutes with wind baffles between each rafter and seal the perimeter top plates with 2-part foam. This will halt wind washing through the fiber glass insulation and ensure a clear ventilation space when additional insulation is installed.

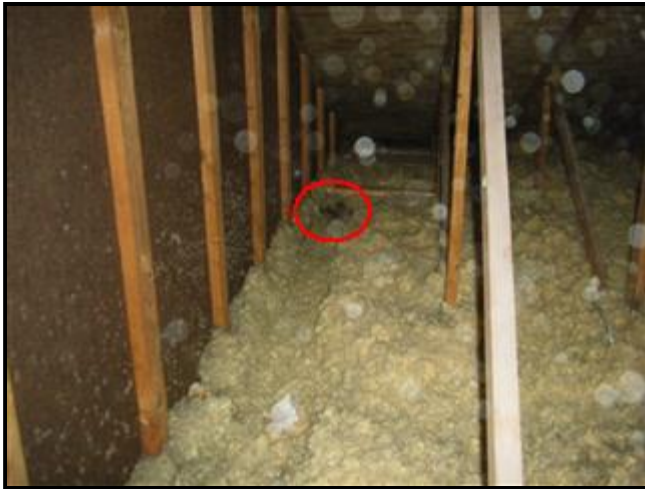
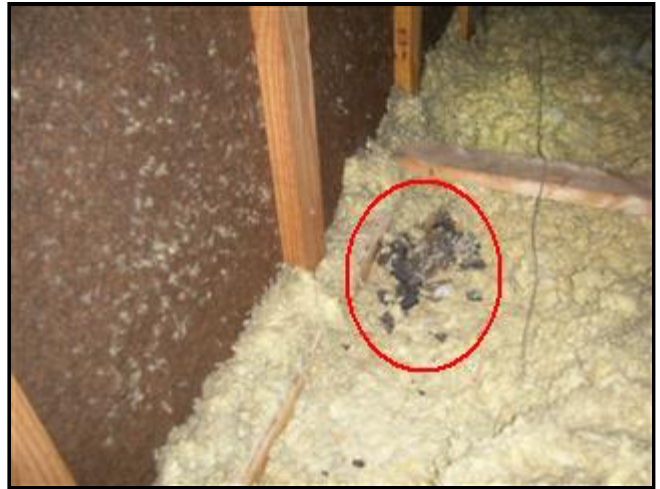
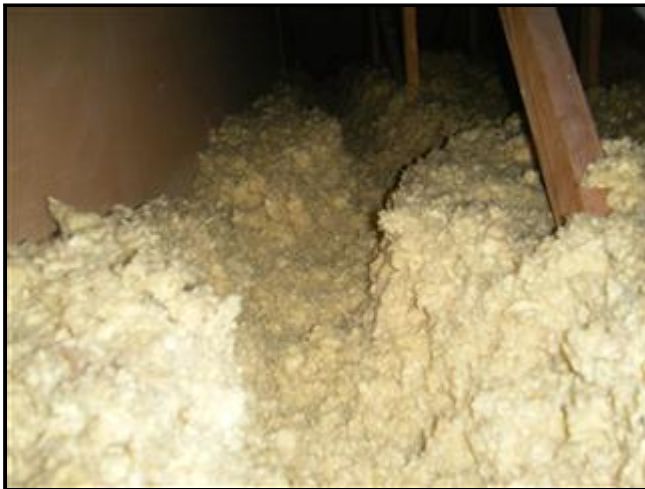
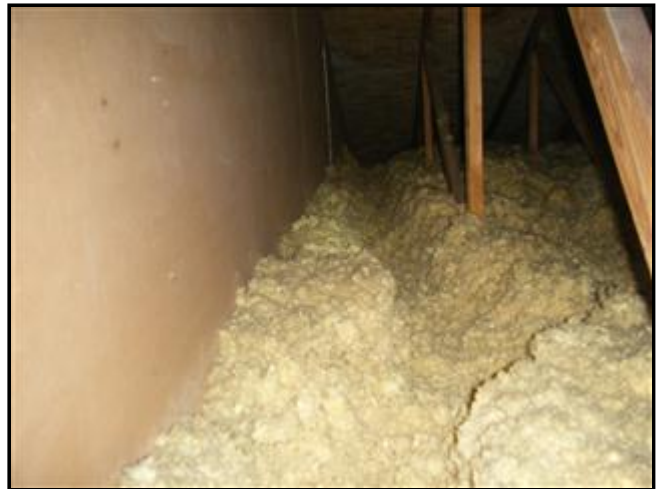
There are trails, feces and insulation moved around in the attic from a reported raccoon. Likely entry points seem to have been sealed. Recommend areas of soiled insulation be removed and any damage found be repaired before air sealing and insulating the attic.

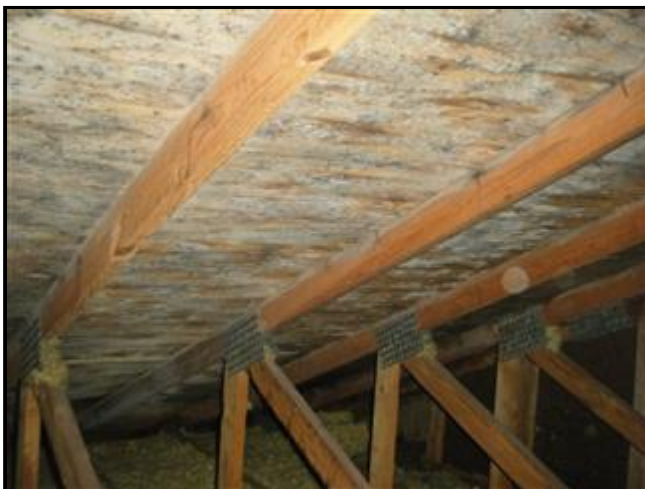
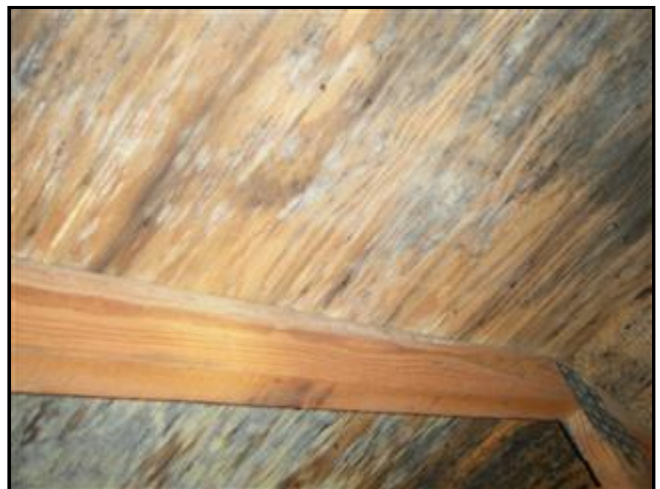
The roof sheathing is discolored and mildewed along the north side of the building. Care should be taken by laborers in the attic to wear appropriate personal protective equipment including respirators. See Items 2.2, 2.4 and 4.1 regarding managing attic moisture.

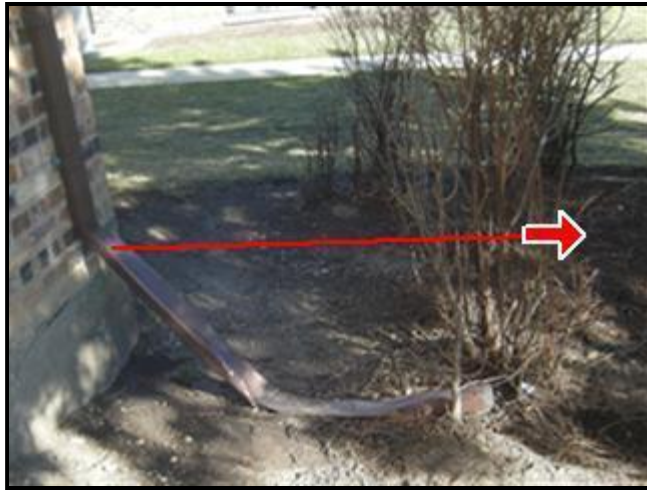
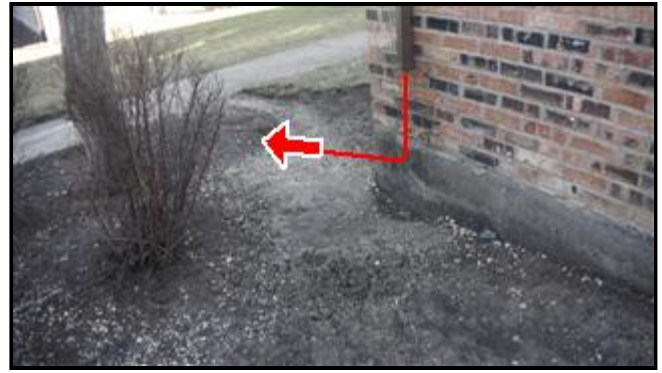
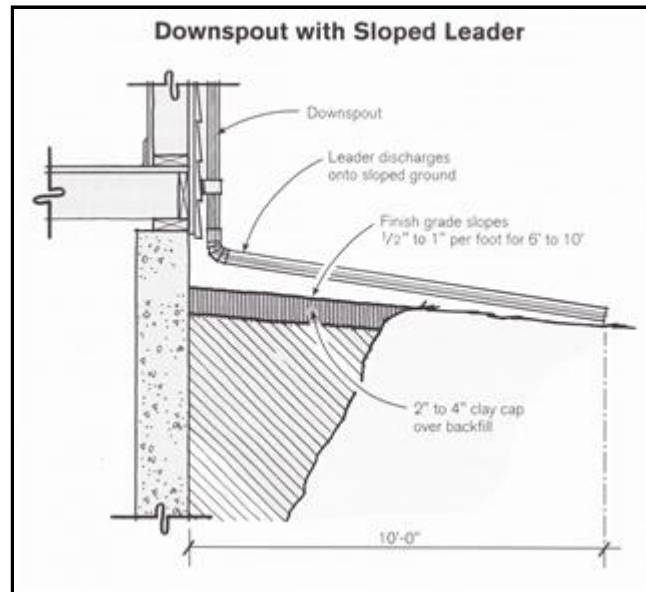
The gutters are in fair condition and seem to be managing rain water effectively. Recommend monitoring during rain events to determine whether additional downspouts are needed (wherever rain is spilling over gutters).

The downspouts around the exterior need attention. Recommend that all downspouts extend about 6 feet away from the building. This is to ensure that the drainage water does not seep into the ground and back to the foundation. Recommend repairing all connections between downspout assemblies to ensure that water is draining from top to bottom without any restrictions.

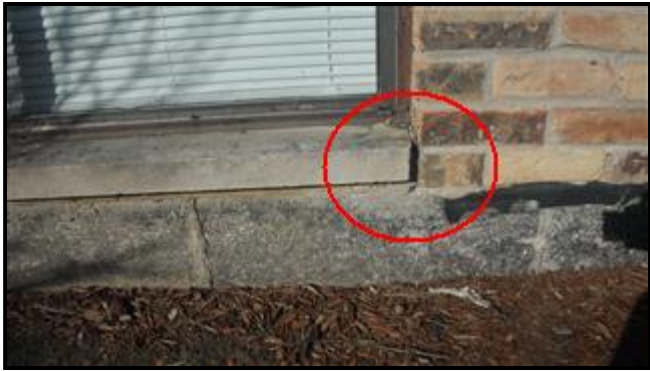
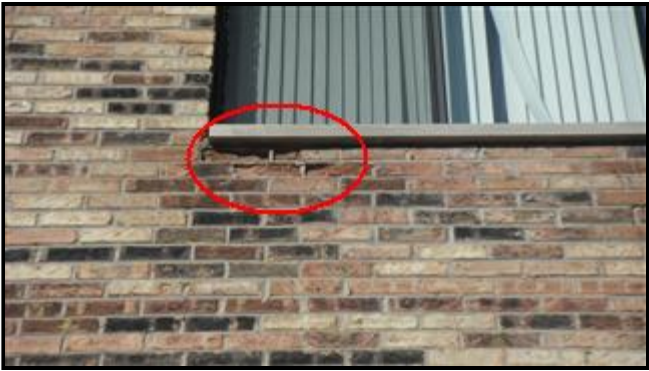
- Areas of mortar joint at the sills are open and allowing moisture into the wall. Recommend a qualified masonry contractor properly seal these joints with mortar or exterior grade sealant. All exterior caulk should be periodically inspected for any failures and re-caulked as needed.

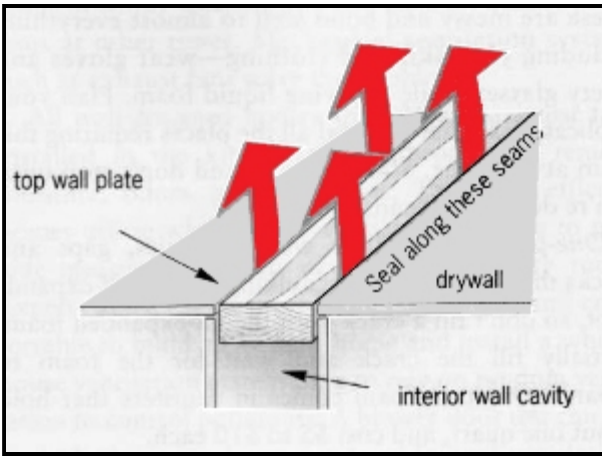
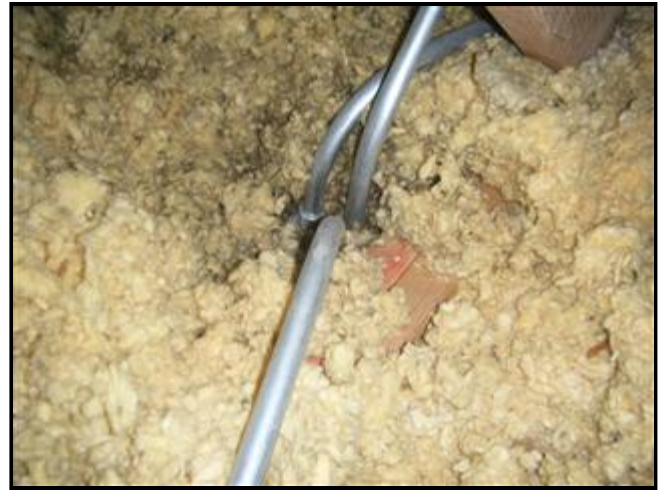
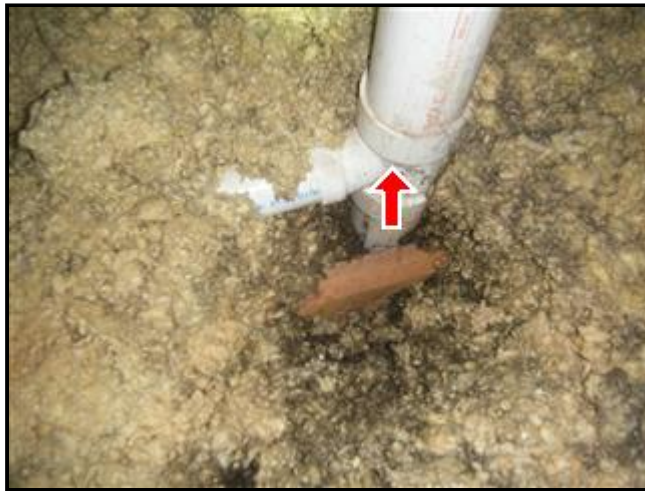
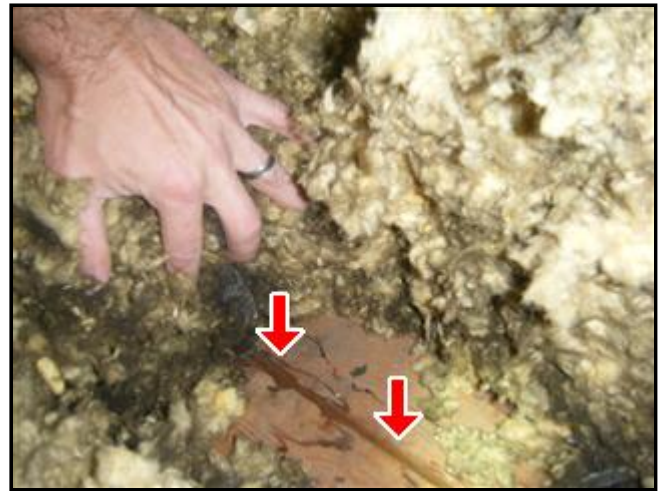
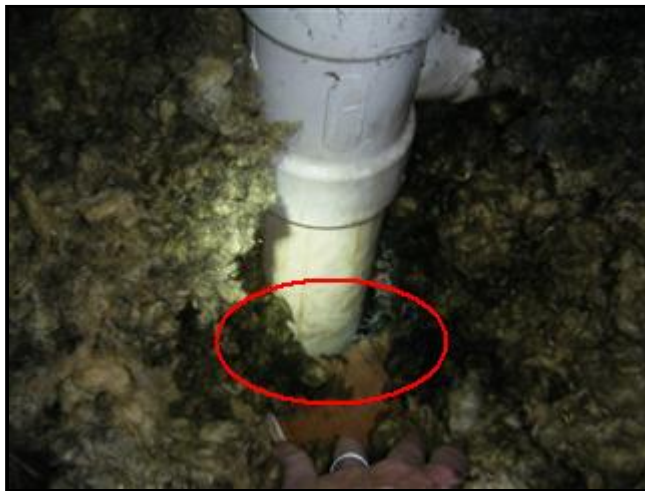
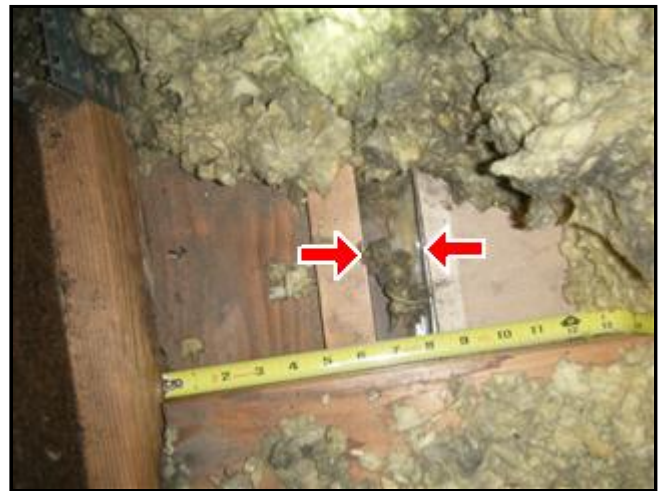
- As the framing dries over the years, the top plates of both interior and exterior walls allow large amounts of air to leak from the wall cavity and up into the attic. Recommend that these areas be sealed with a 2-part foam spray.
- Penetrations in the form of plumbing penetrations, electrical conduit, boxes and fixtures should be exposed and sealed before additional insulating.

4.0 Picture 6 Gap along west & east walls in attic

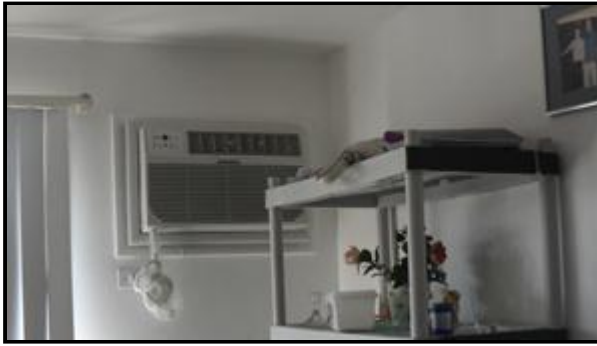
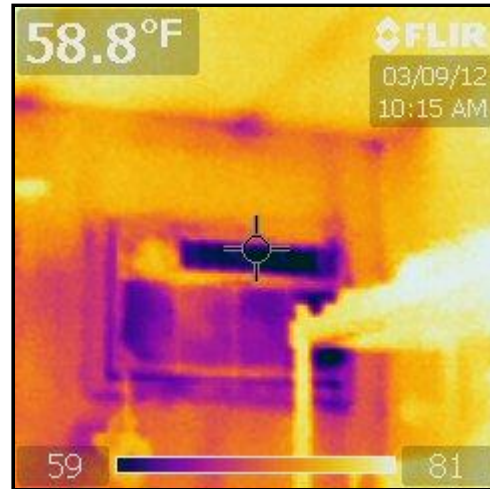
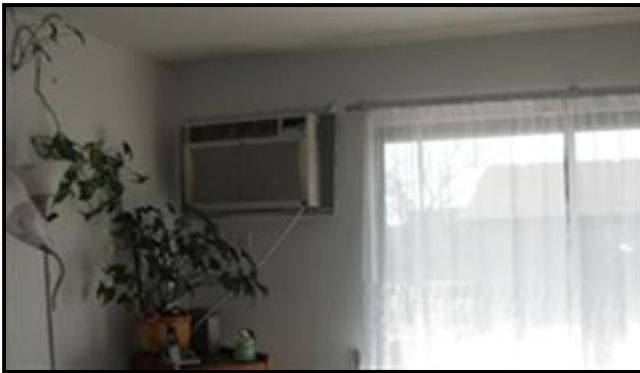
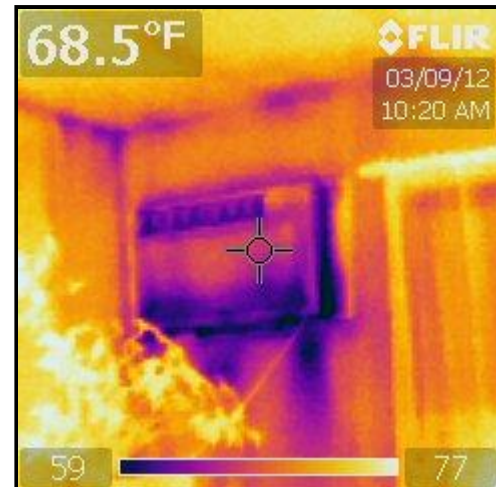
The sleeve-unit air conditioners are a significant source of air leakage in the units. The cold metal surfaces also condense interior moisture, leading to mold/mildew on the painted surfaces. Recommend insulated AC covers be fabricated and installed on the interior. The sides of the cover should be permanently affixed while the insulated flat cover should remove and store easily.

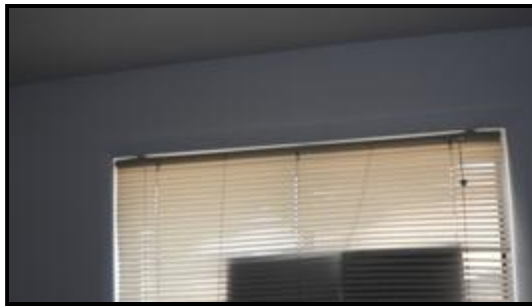
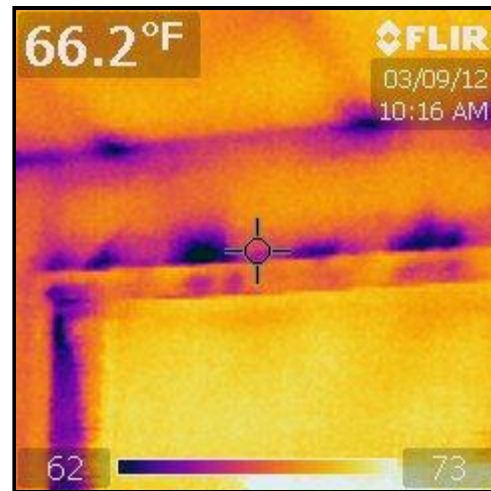
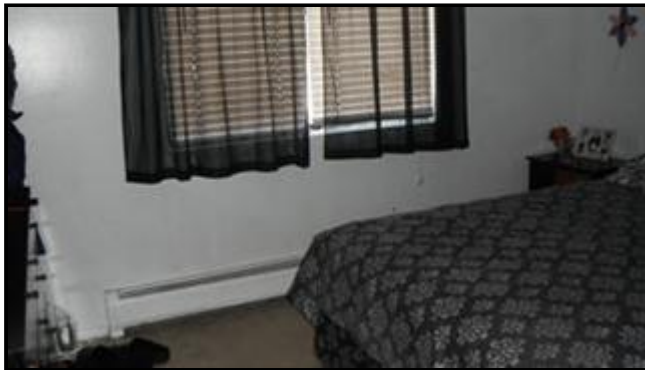
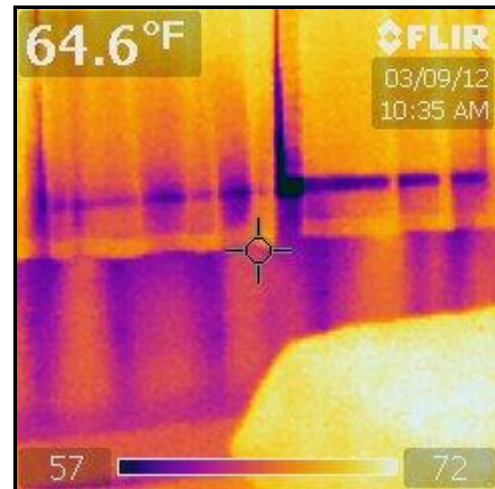
The aluminum windows are performing poorly - significant condensation and air leaks are obvious. After air sealing and insulating the attic, replacing the windows and patio doors is the next best opportunity to improve the durability, performance and comfort of the building. Recommend windows with a low U-factor - <0.3 - with a thermally broken frame be installed by a qualified contractor and air sealed with foam and/or caulk to halt all window air leakage.

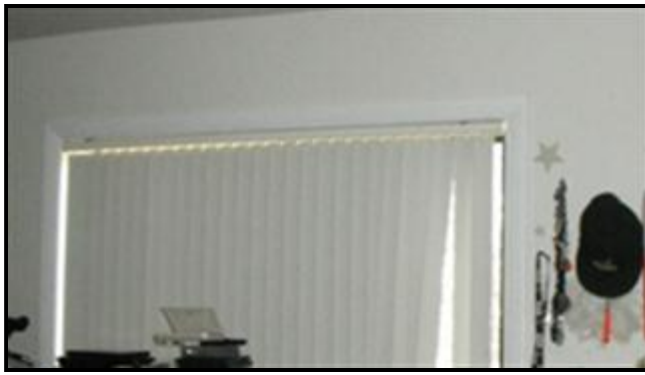
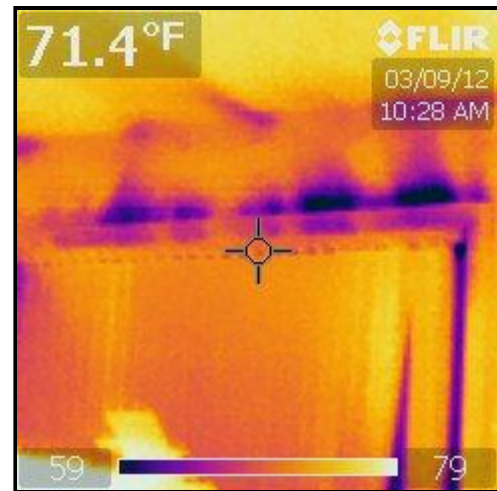
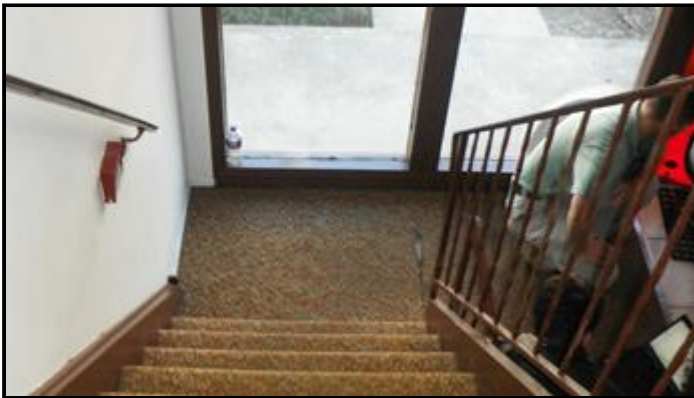
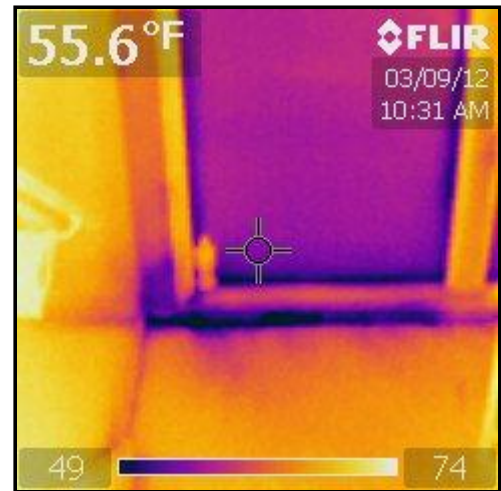
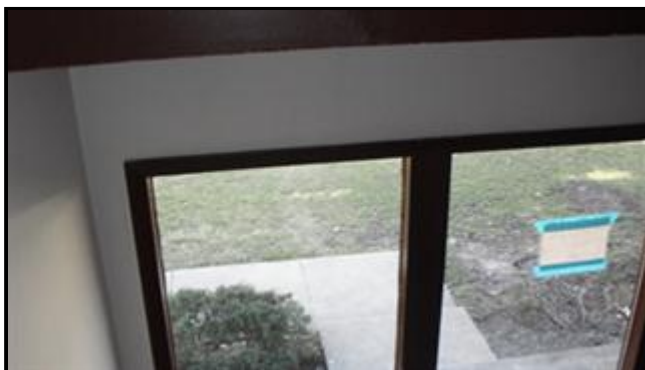
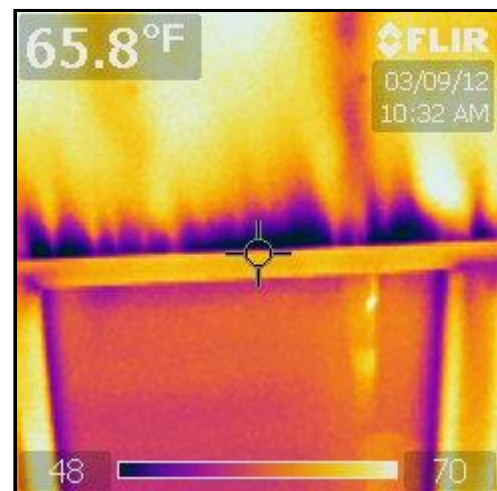
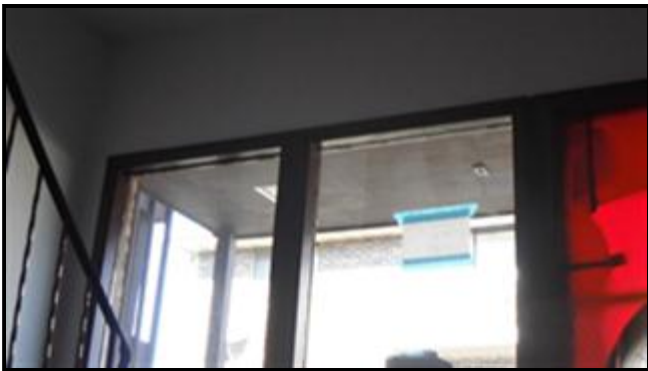
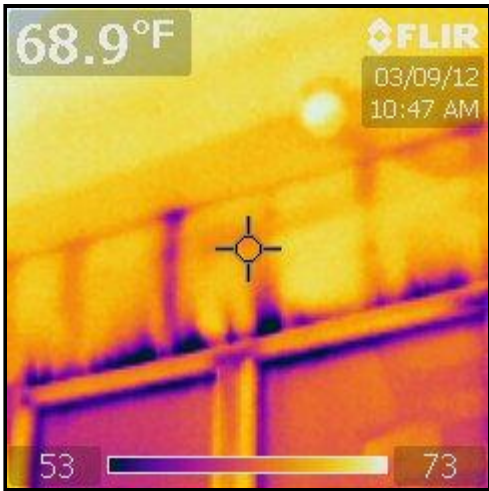
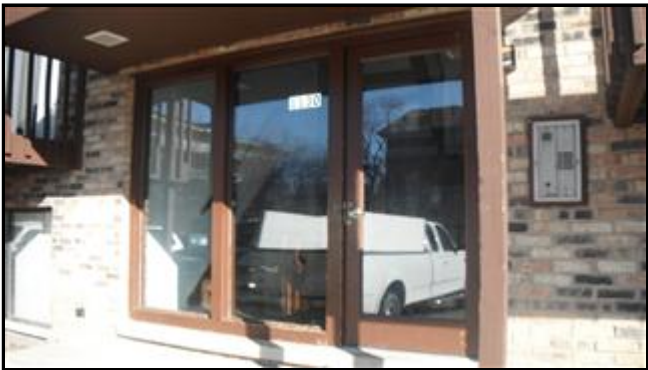
- The wood entry doors are performing poorly - significant air leaks are obvious. After air sealing and insulating the attic and replacing unit windows, replacing the entry doors is the next best opportunity to improve the durability, performance and comfort of the building. Recommend doors with a low U-factor - <0.3 - with a thermally broken frame be installed by a qualified contractor and air sealed with foam and/or caulk to halt air leakage.

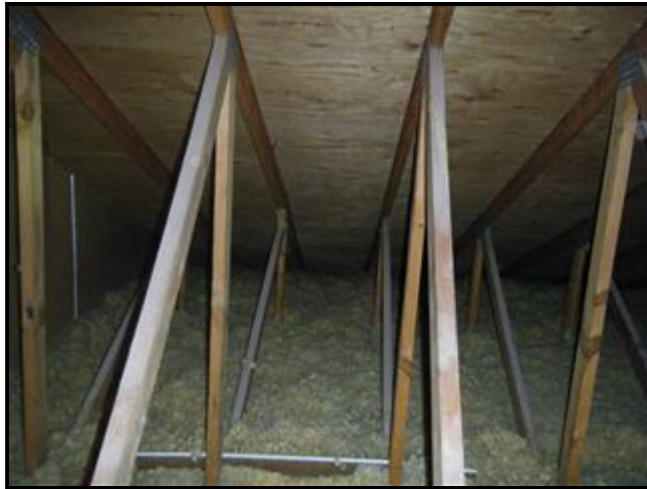
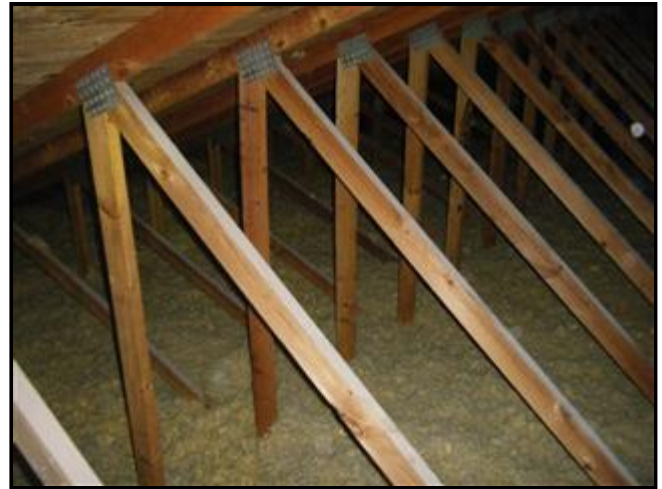
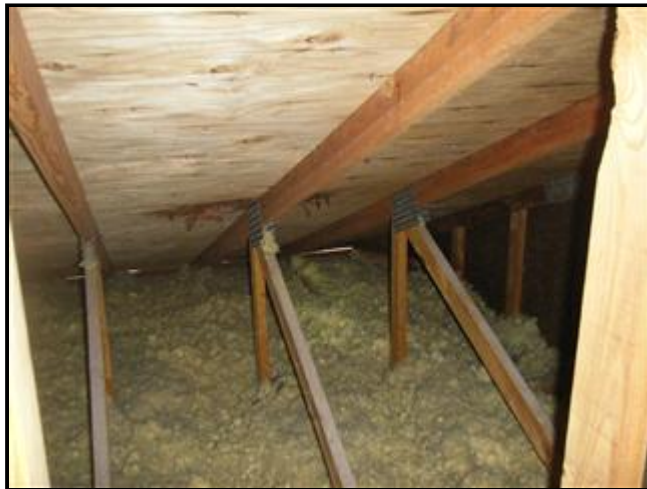
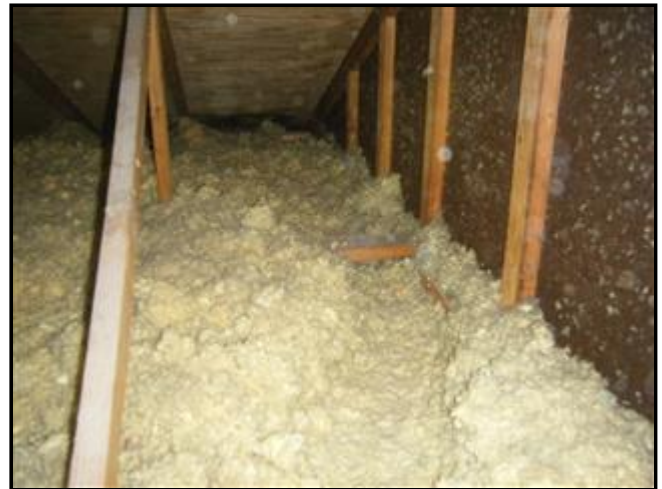
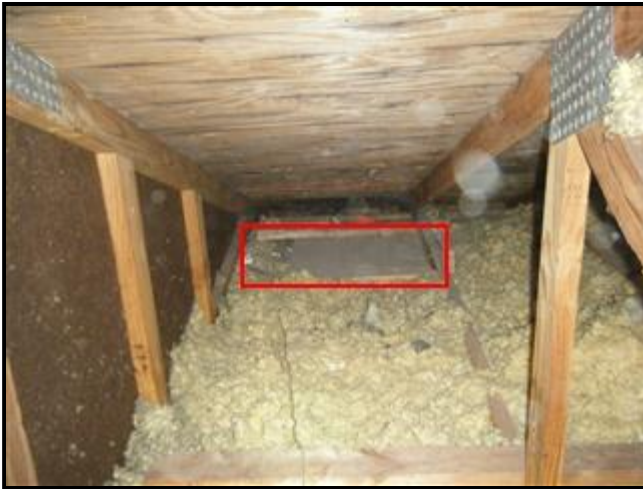
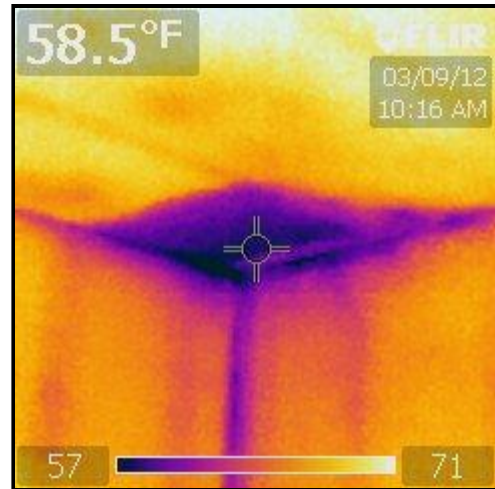
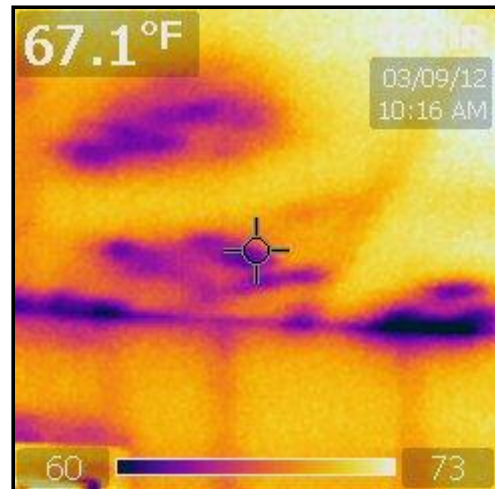
The attic currently has blown fiberglass insulation at about R - 15-20, below the current code minimum of R-38. Recommend the attic be insulated to a more cost effective R 50-60 with blown cellulose (settles to an air-impermeable mass - unlike fiber glass), **only after air sealing and attic ventilation** issues have been completed.

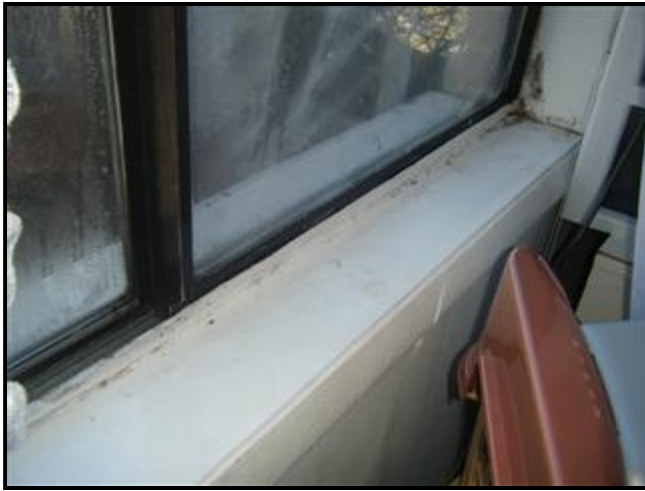
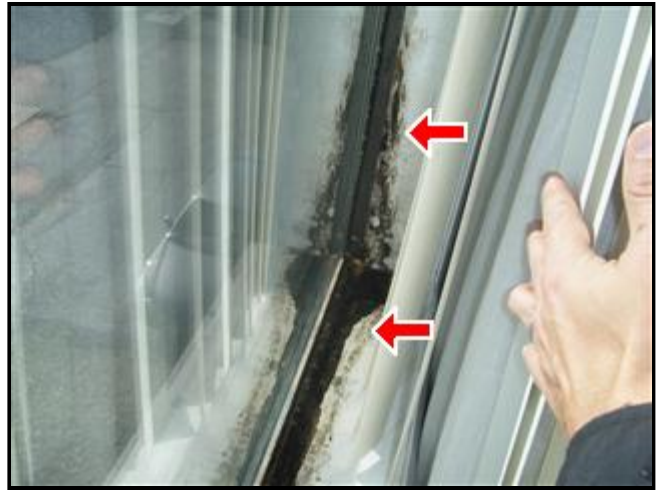
Thermally conductive aluminum windows are condensing moisture and leading to mold & rot. Replacement windows should be thermally 'broken' with a low U-factor - <0.35.
