Home Performance Report

115 E. Ogden
Naperville IL

Insight Property Services, Inc

Date: 1/1/2013	Time: 09:15 AM	Report ID: HP-111008
Property: 115 E. Ogden Naperville IL	Customer: T. Smith	Real Estate Professional:

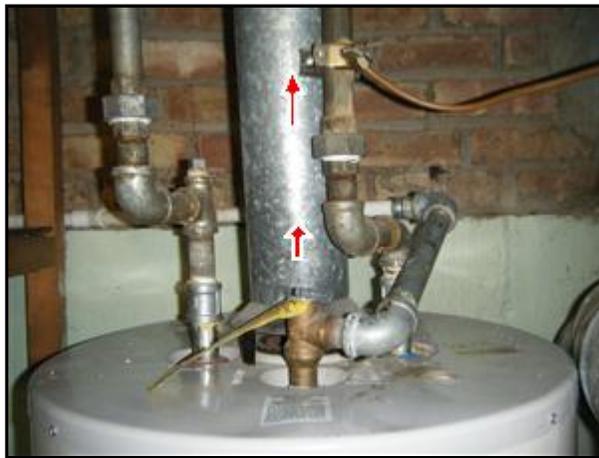
2.7 Picture 1

+ **Spillage Test Results:** A spillage test was conducted on the water heater under Worst Case Depressurization. According to BPI Technical Standards, combustion appliances may spill fumes for up to 60 seconds upon start up. **Your water heater vent spilled beyond 60 seconds and "Failed" the spillage test.** The spillage was off to the right side and stopped soon after a minute. This is likely due to an obstruction in the exhaust flue and air flow from duct leaks nearby.

+ **Minimum Draft Pressure Test:** This test is to determine if there is enough "draw" or negative pressure that will remove the toxic exhaust fumes in the flue of the water heater to the outdoor air. **The Draft Pressure reading on the water heater during "Worst Case Depressurization" was -1.8 Pa.** This number should be more negative than the Minimum Required Draft Pressure of **-1.5 Pa**.

Even though the draft pressure was more than the minimum, it is not strong enough to draw away all the exhaust gases resulting in partial exhaust spillage. Recommend the flue and chimney be inspected, cleared of any debris and a liner installed to foster stronger draft. A Combustion Safety Test should be performed after repair are made.

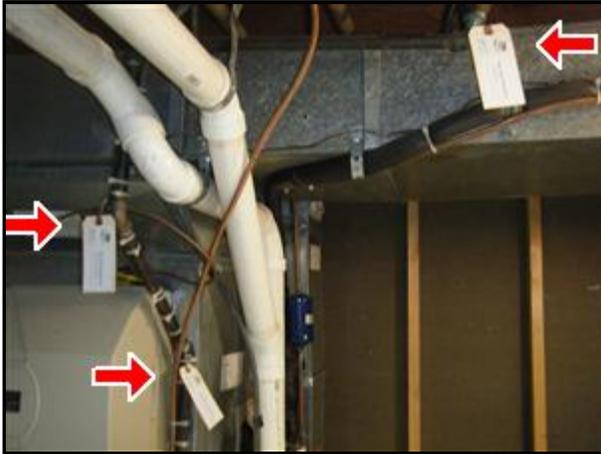
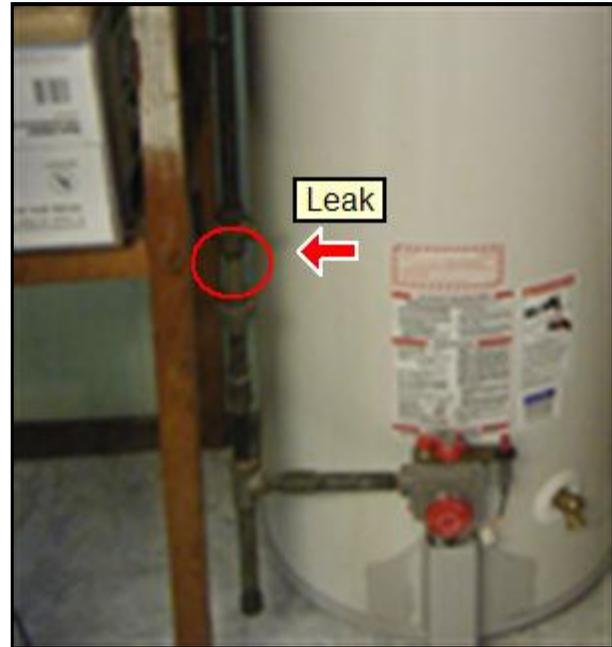
- + Gas leaks were detected and tagged near the water heater and furnace. A qualified individual should repair and re-test the gas leaks as soon as possible.

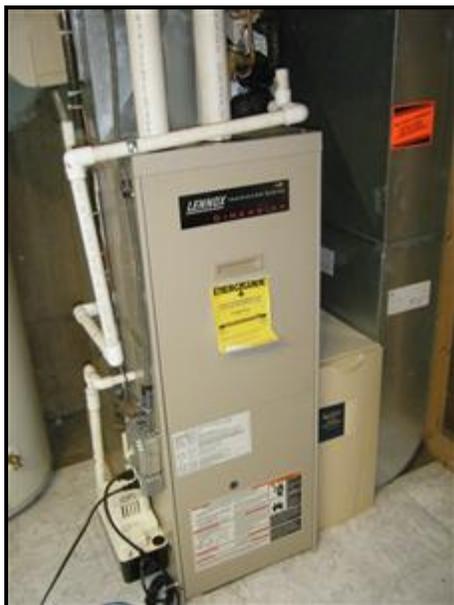
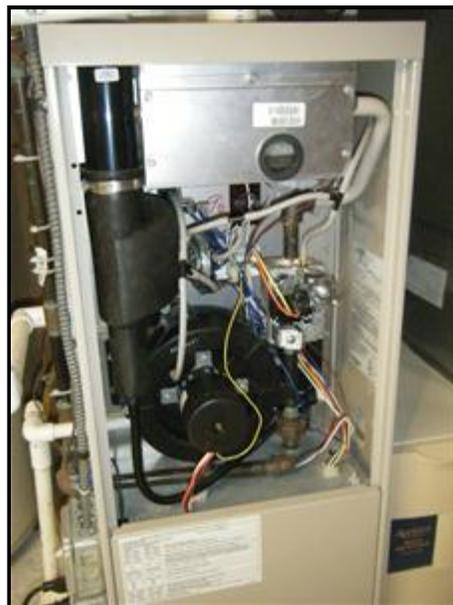
The furnace is about 10 years old, 93% efficient and seems to be functioning well. Recommend the filters be changed regularly (as often as once a month with pets in the home) and the unit be serviced regularly (twice a year) to ensure continued proper function.

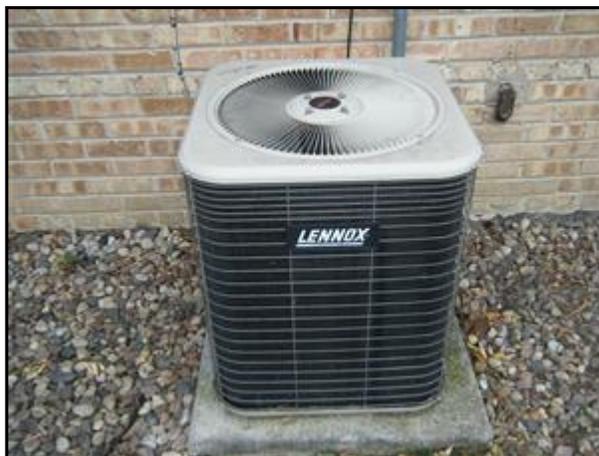
3.1 Picture 1

The air conditioner is at least 8 years old, of an estimated life span of 20 yrs. The unit would benefit from regular cleaning and service. Debris and lint hinder airflow and increase the load on the unit, resulting in decreased efficiency and service life of the units. Recommend the unit be cleaned by a qualified HVAC technician before the air conditioning is used next summer.

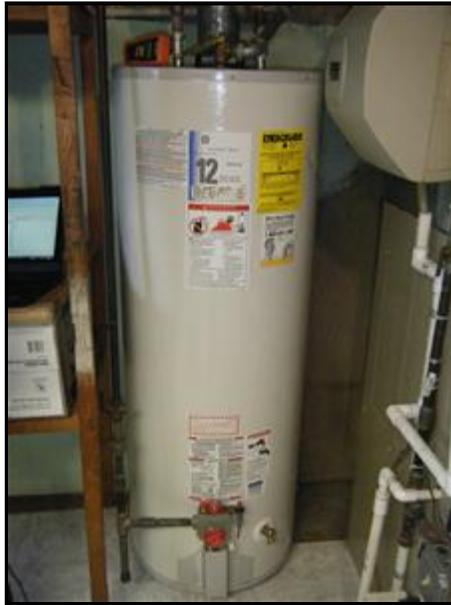
3.2 Picture 1

The existing water heater is 8 years old of a typical life span of 12-15 years. Should a repair costing more than \$200 be needed or the unit starts to leak, strongly recommend upgrading to a power vented, tanked water heater. These units provide greater efficiency and combustion safety for a marginally greater cost. Sealed combustion, tank-less units can supply an 'endless' stream of hot water, although their greater initial cost results in a longer payback period. Both types of water heaters are more energy efficient and they eliminate combustion safety risks due to exhaust spillage.

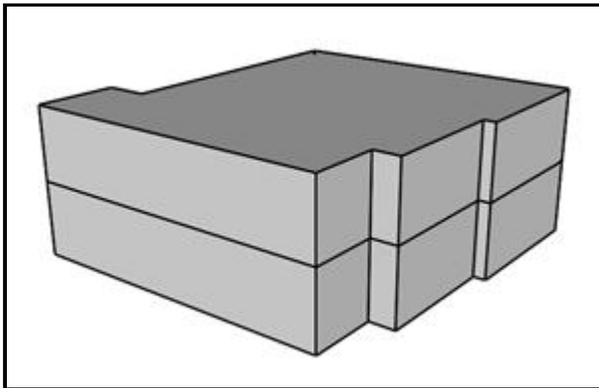
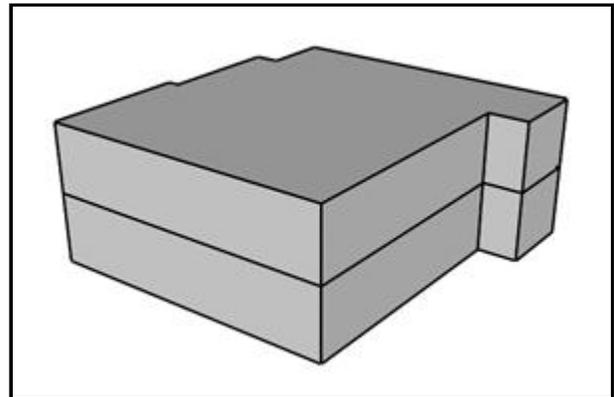
The "Thermal Boundary" of your home is what separates the conditioned air inside from the outside air, attic or attached garage. Typically the thermal boundary is made up of an air control layer (like gypsum board) and a thermal control layer (insulation). A thermal boundary has 6 sides (top, bottom, front, back and two sides). Anywhere along the thermal boundary that is not aligned properly (gaps or missing areas), energy loss can occur. Summer heat gain and winter heat loss can result from uncontrolled heat flow and air flow through these breaks in the thermal boundary. It is important to preserve and complete the air & thermal boundary by air sealing and insulating when remodeling.

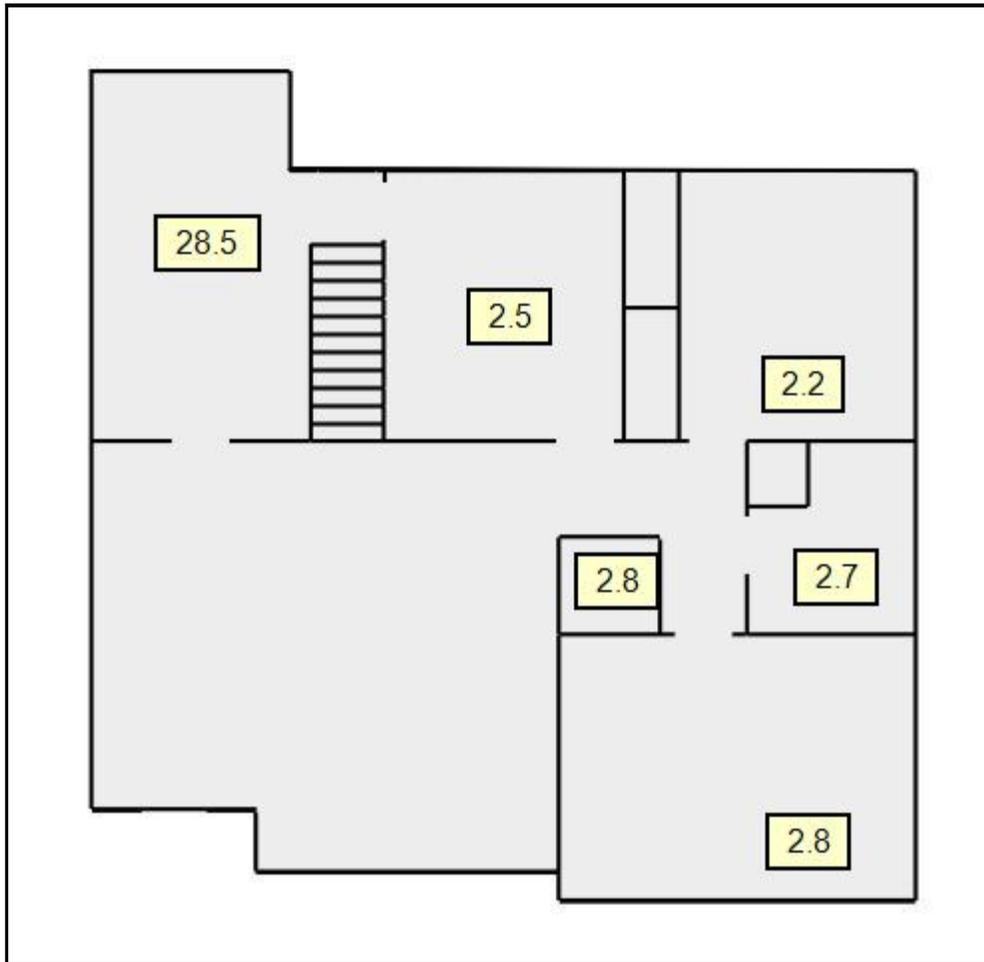
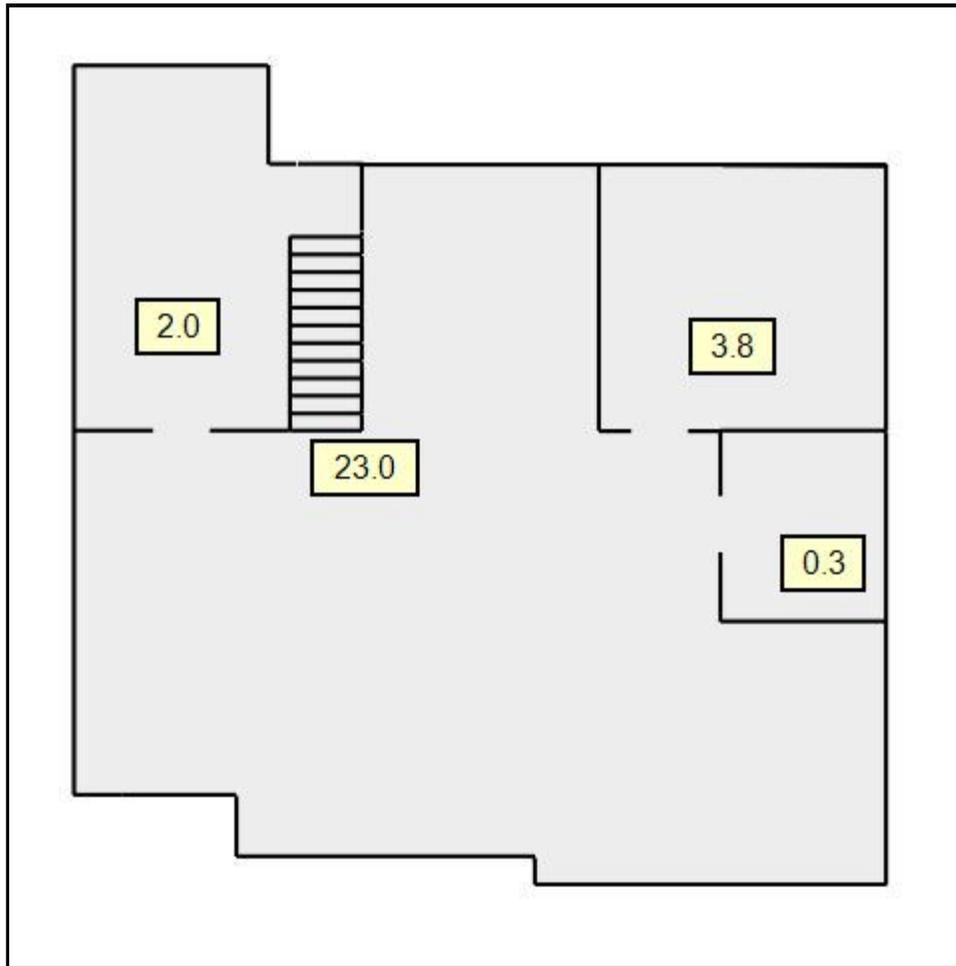
With the home depressurized to -50 Pa, rooms were closed and the pressure difference measured tells how much pressure relief is resulting from leaks to the outside. 0 is no leaks. 50 is "open door" leaky.

The basement leakage was a very significant 23 Pa, much of it coming by way of the exterior wall cavities and other bypasses leading to the attic. (28.5 Pa measured in the kitchen was largely from the open door to the basement.)

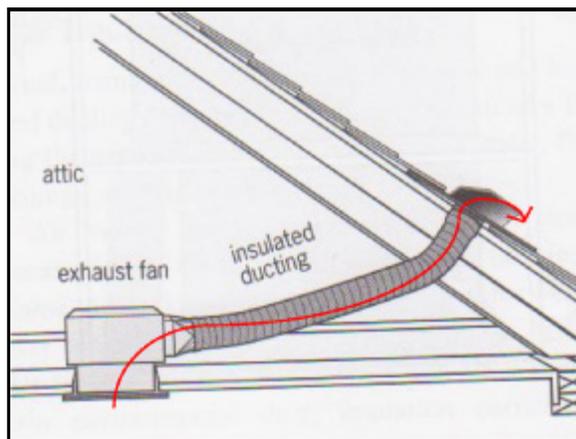
4.6 Picture 1

- It is recommended that every bathroom with a tub or shower have a high-quality, quiet (<1.5 sones), 80+cfm exhaust fan installed. These fans should be exhausted to the outdoors by way of insulated ducting through a roof mounted, dampered vent. A fan should be installed in the 1st floor bathroom before any insulation is added to the attic.

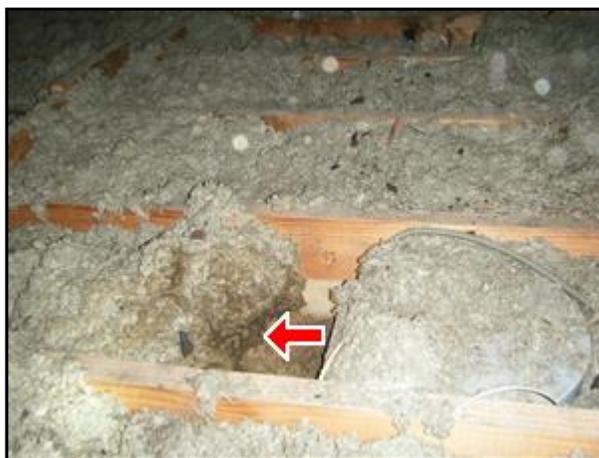
4.7 Picture 1

- The existing kitchen fan moves an impressive 250+ cfm of air! However, the fan is not positioned well to draw off odors, gases and moisture from cooking. And the fan exhausts into the attic, moving insulation and allowing moisture to condense inside the attic.

When the kitchen is remodeled, a vent hood should be installed above the stove and its exhaust should be vented to the outside through a proper exterior, dampered vent.

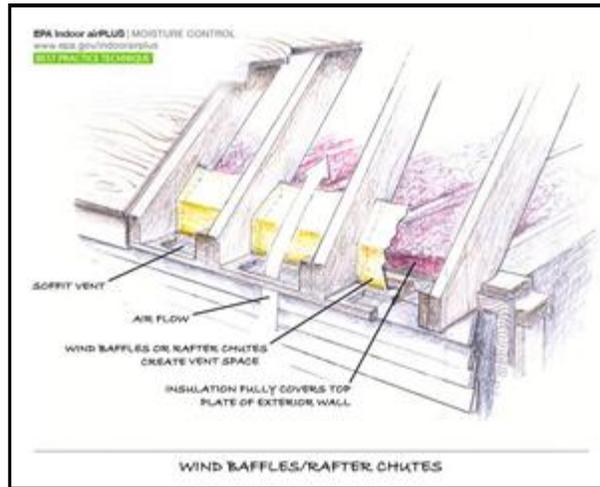
4.8 Picture 1

- Ventilation of the attic is important for two reasons, temperature and moisture control. During the summer, ventilation reduces heat that builds up in the attic during the day. Ventilation also manages moisture produced within the home that moves into the attic through gaps in the ceiling air barrier, removing it before it can condense and cause damage.

The attic currently does not contain vent chutes with wind baffles. Recommended to install vent chutes with wind baffles between each rafter and seal the perimeter top plates with 2-part foam. This will halt wind washing through the insulation and ensure a clear ventilation space. Sealing the wind baffles at the perimeter wall will also seal the leakage gap between the inside brick and the plaster walls. **See Item 6.5**

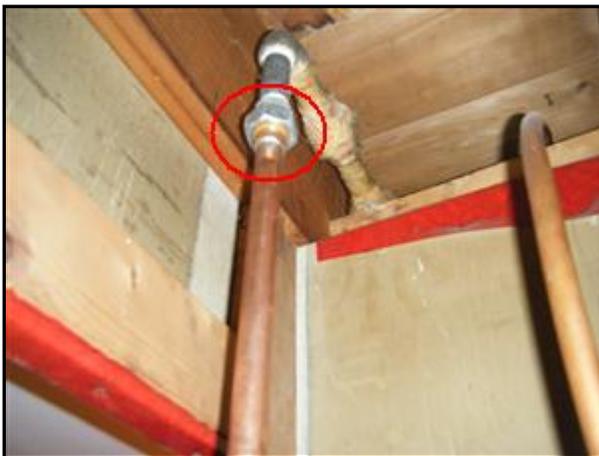
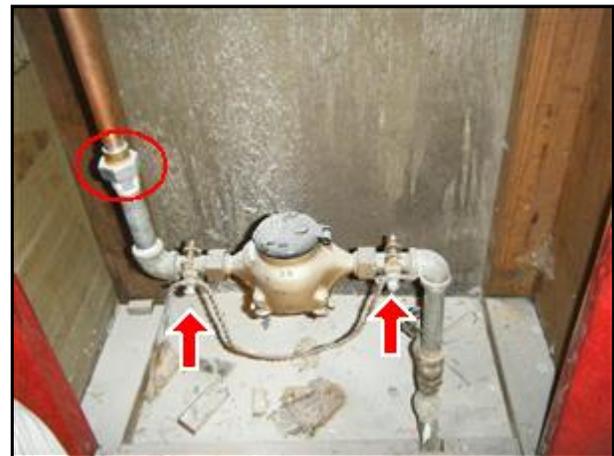
There is no bonding wire across the copper pipe section above the water meter. The dielectric unions effectively break the 'ground' that water pipes generally provide. A bonding wire, similar to that attached across the water meter should be installed across the copper pipe, from the galvanized pipes above and below. Recommend a qualified electrician complete this and inspect the rest of the electrical system for any other grounding or bonding issues. This may be coordinated with the relocation of the electrical service during the addition project.

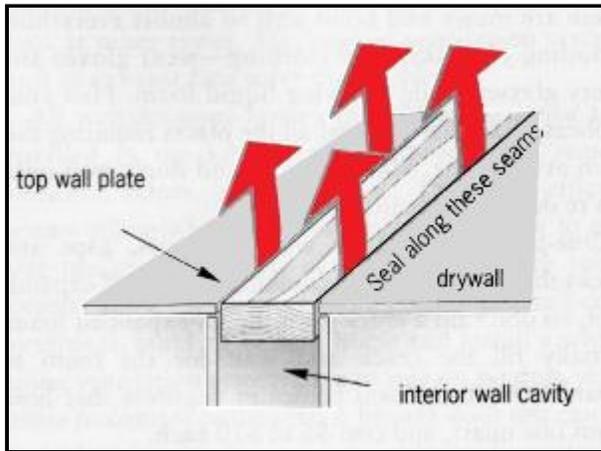
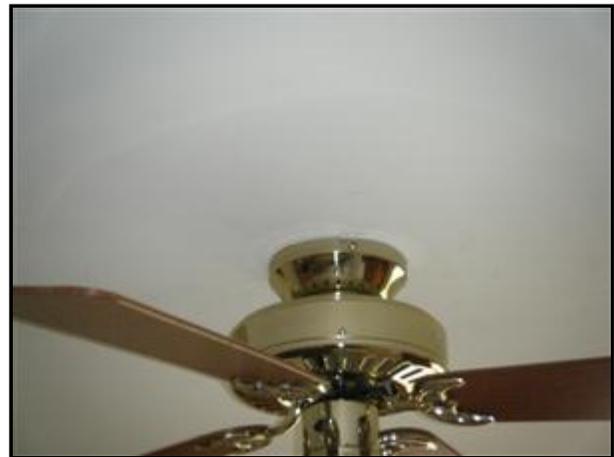
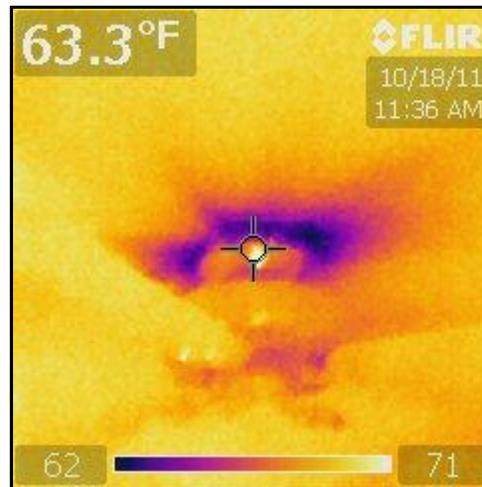
As the framing in a home dries over the years, the top plates of both interior and exterior walls allow large amounts of air to leak from the wall cavity and up into the attic. Recommend that these areas be sealed with a 2-part foam spray.

Penetrations in the form of plumbing penetrations, electrical conduit, boxes and fixtures should be exposed and sealed before additional insulating. The tops of pocket doors should also be air sealed from the attic above.

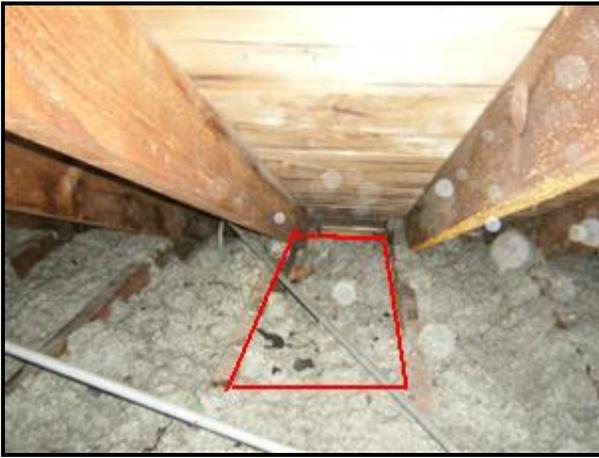
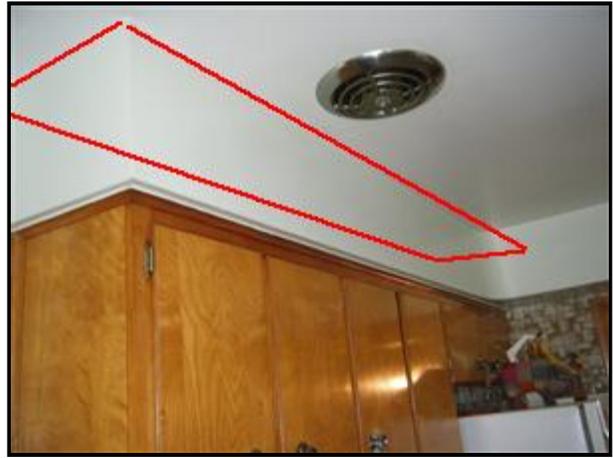
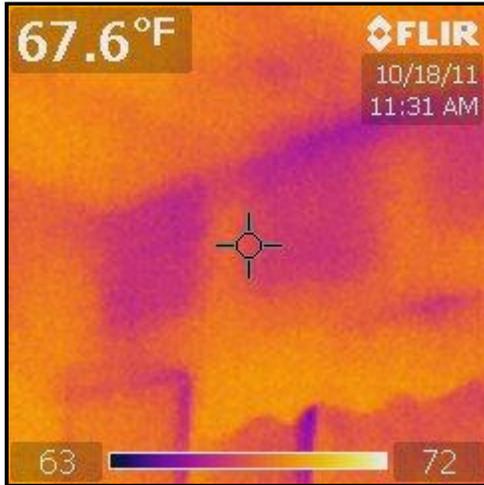
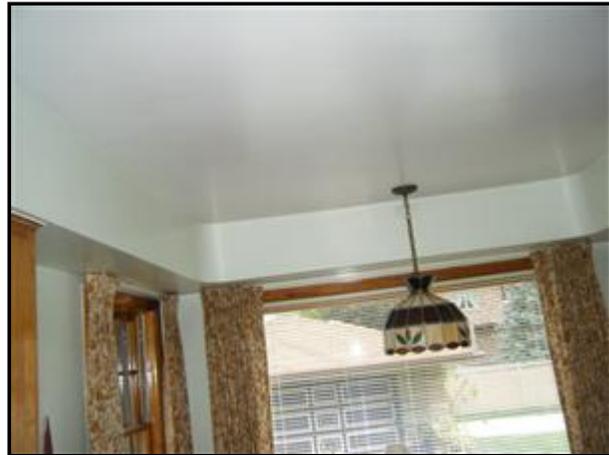
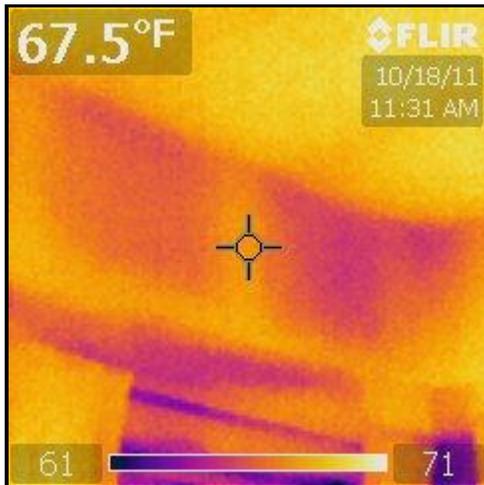
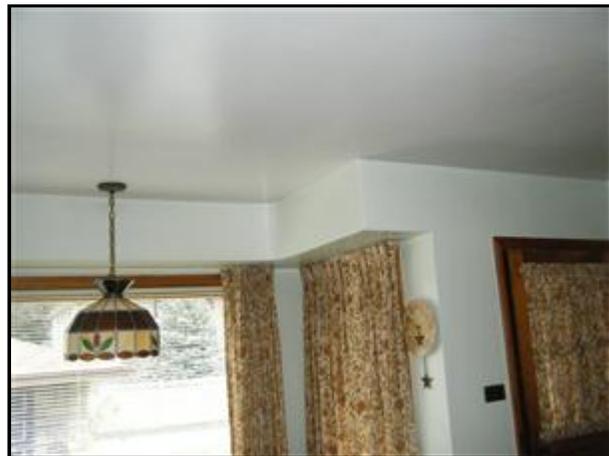
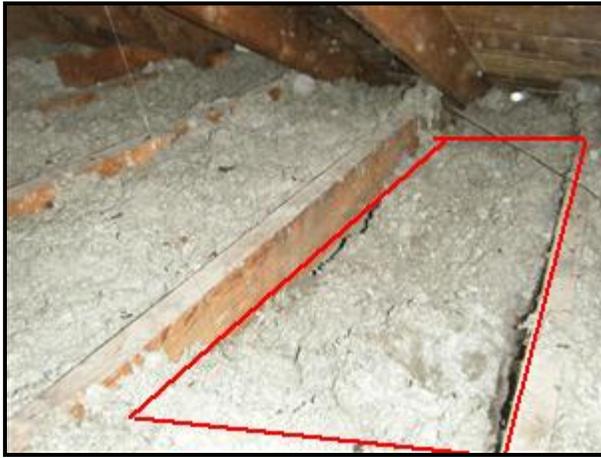
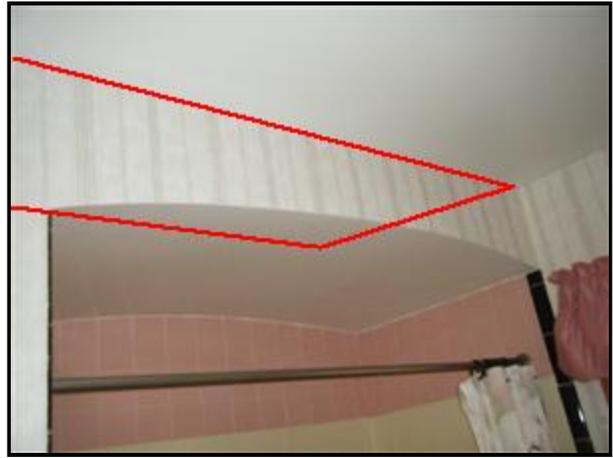
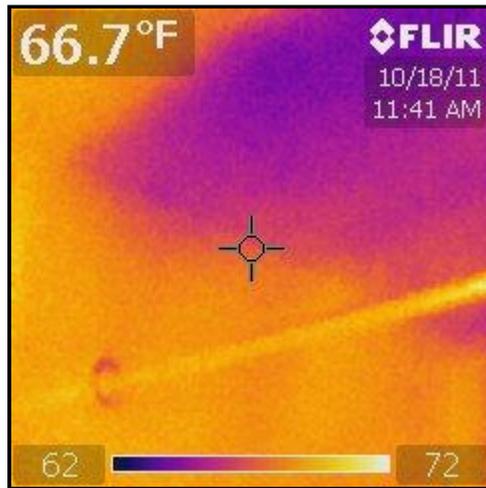
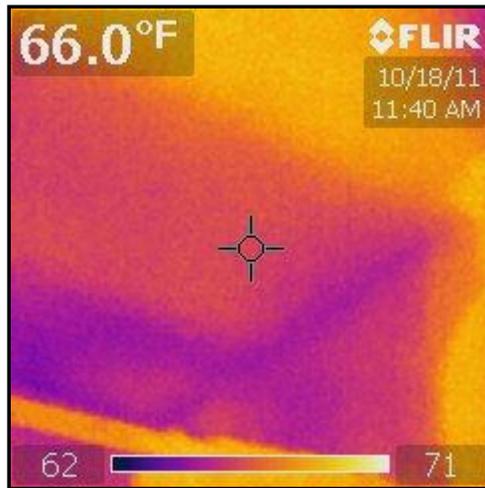
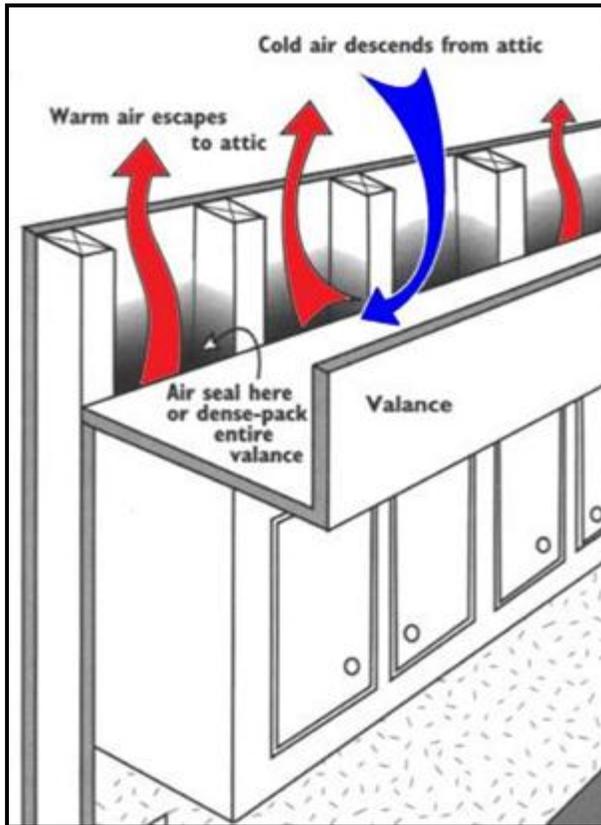
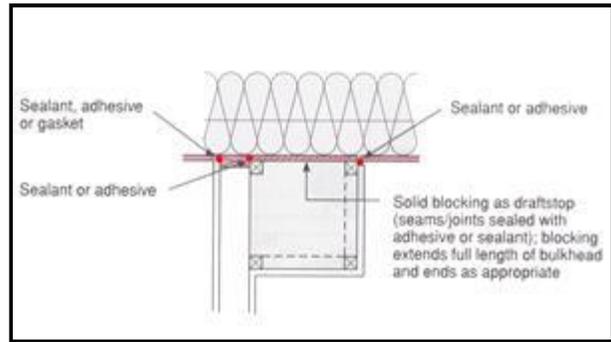
- The top of the soffit should be covered with foam board and sealed to the framing and drywall to create a continuous air tight sealing, the air barrier between the conditioned space and the unconditioned attic. Recommend having a qualified contractor air seal, and insulate the soffit.

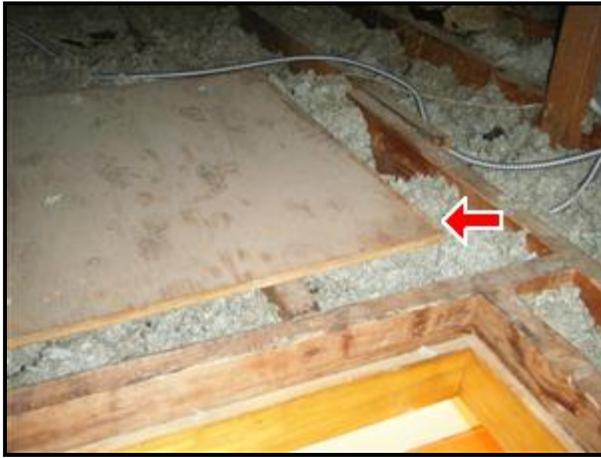
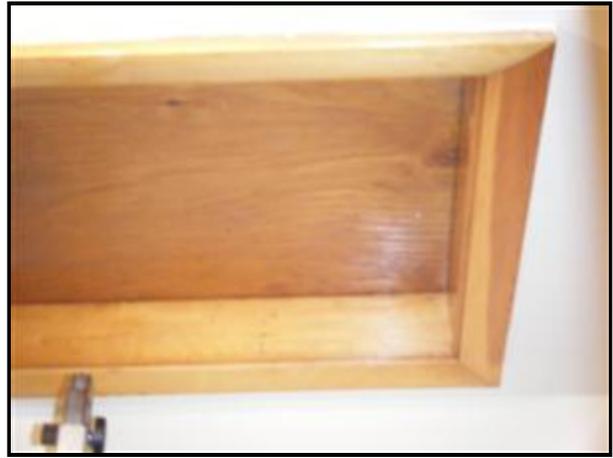
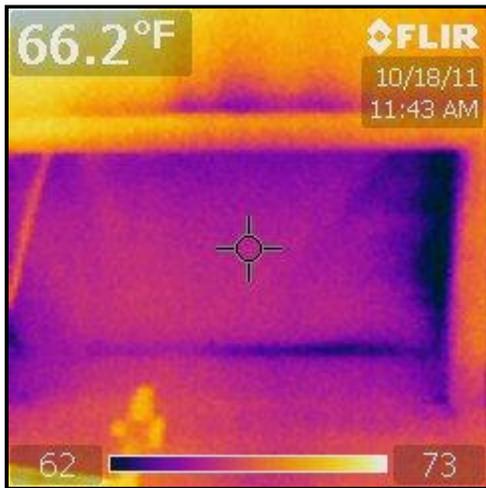
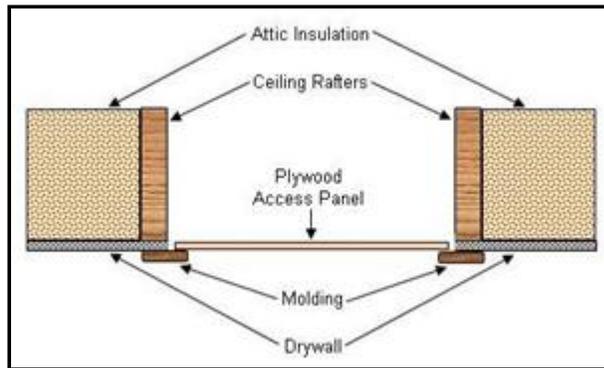
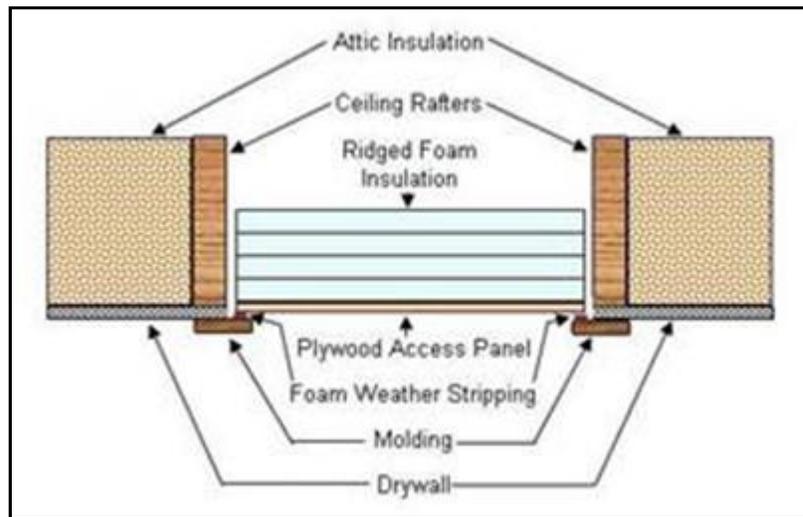
The 1% of uninsulated attic hatch area degrades the overall performance of the attic insulation by more than 30%.

The attic hatch should be air sealed and insulated. The casing should be fastened securely to the ceiling and caulked at all corners & seams. Weather strip should be installed where the cover sits on the casing. The cover should have 8" of foam board fastened to the top, resulting in an R-40 assembly.

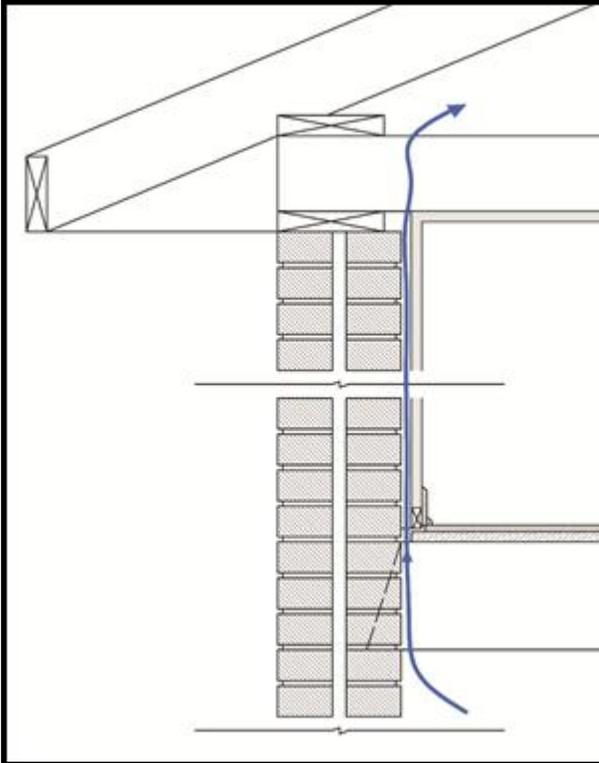
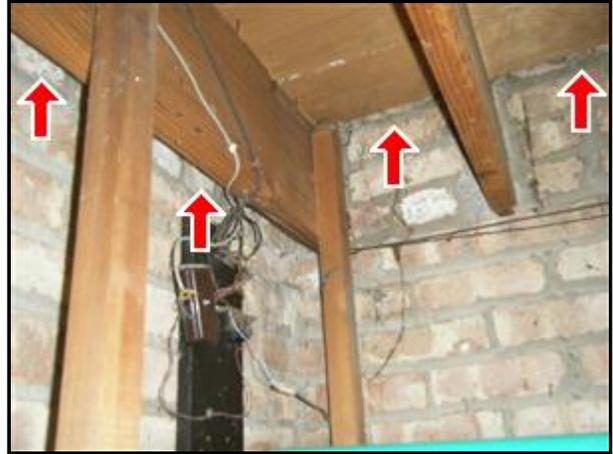
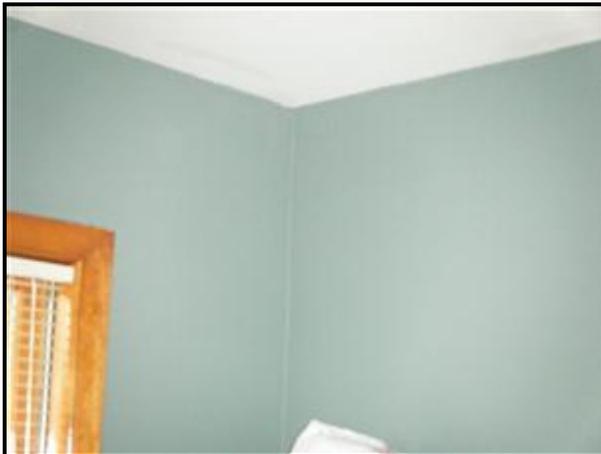
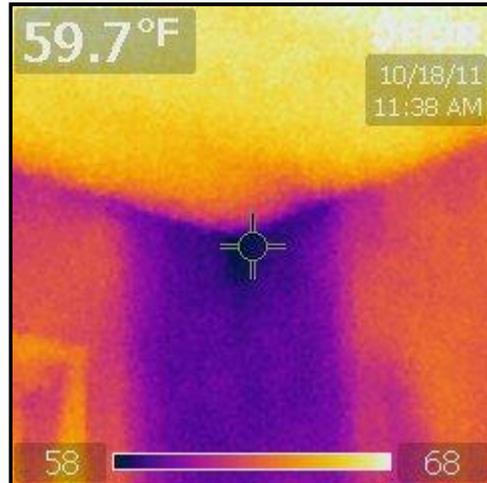
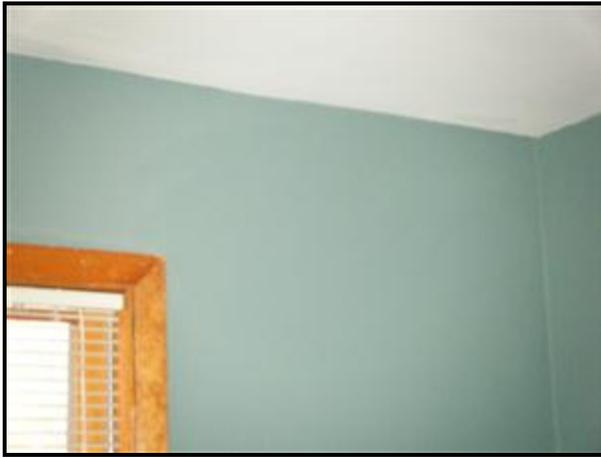
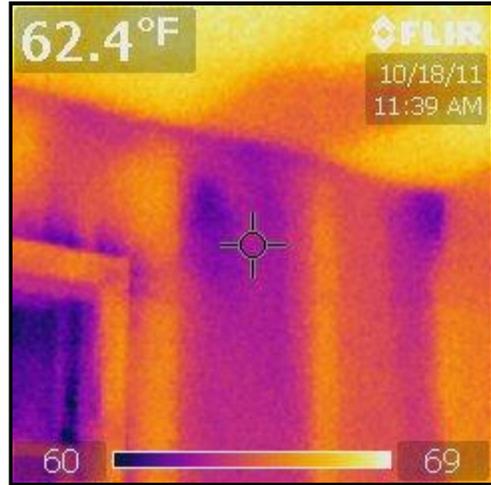
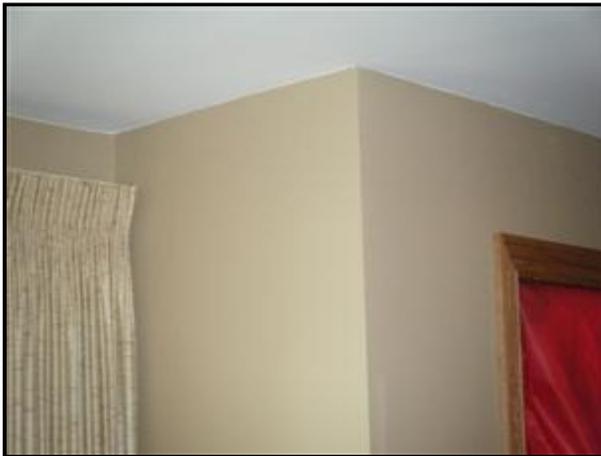
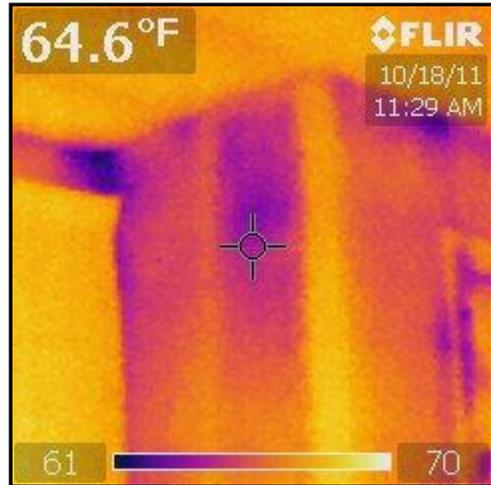
which air enters and leaves the home, resulting in heat gain or heat loss. The space is too small to cost effectively insulate but can be sealed with expanding foam at the attic or basement (or both) to stop this uncontrolled air flow. This bypass is the single largest air leak in the home.

Considering the basement is largely finished, this area is best accessed from the attic, along the exterior wall and may be sealed as part of installing and sealing vent chutes with wind baffles into place. **See Item 4.8**

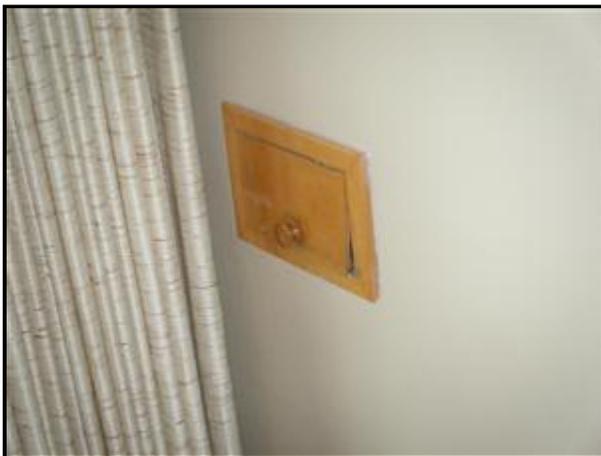
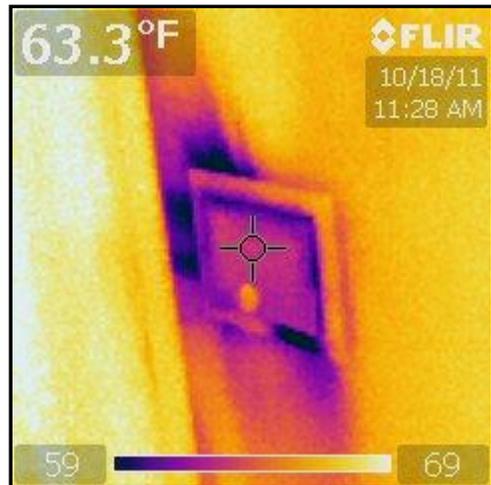
- The pass through mail box is a significant source of leakage in the home and should be insulated, sealed off and removed (interior door at least). An exterior mounted mailbox would need to be installed in its place.

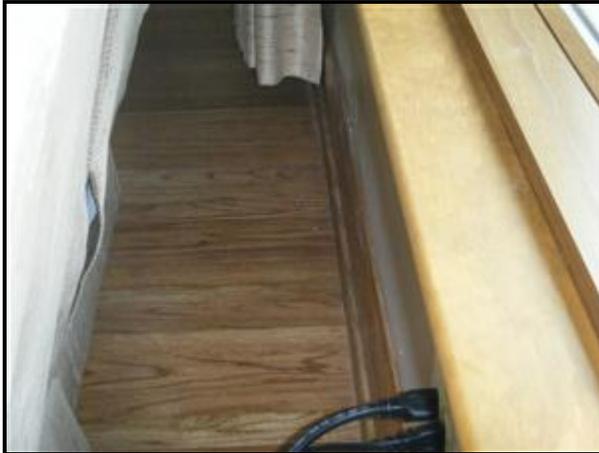
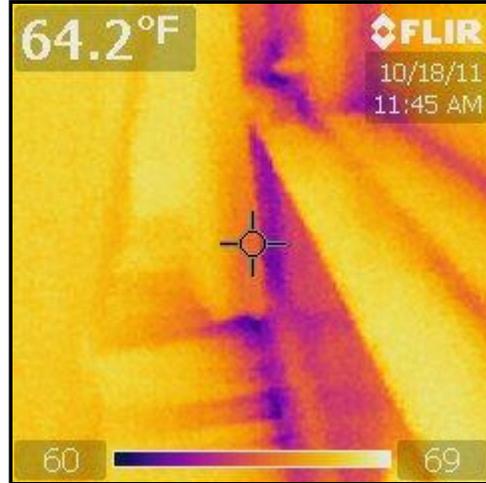
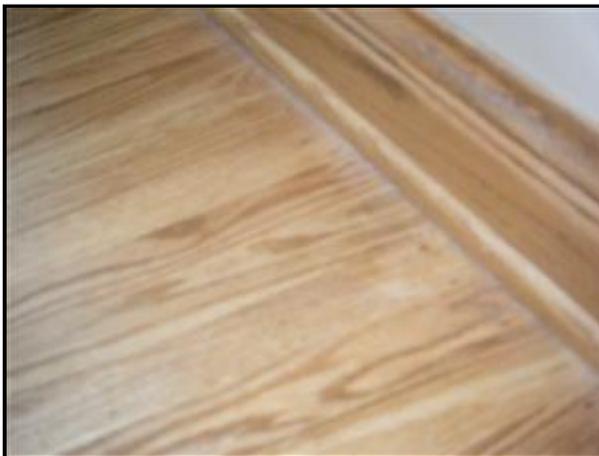
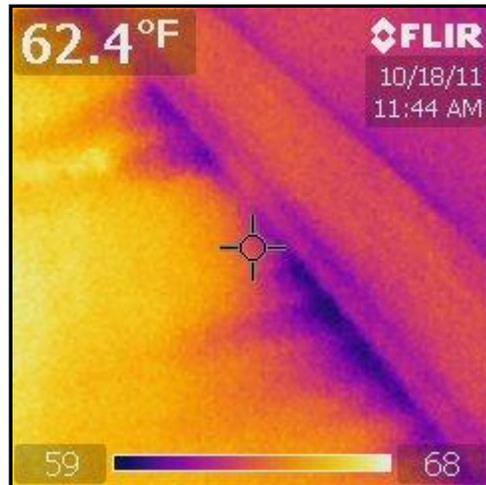
Some air leakage was detected along the baseboards. Air sealing wall air bypasses at the attic and/or basement will likely halt most of this baseboard leakage. Any remaining leakage after air sealing may be sealed with a clear, paintable caulk.

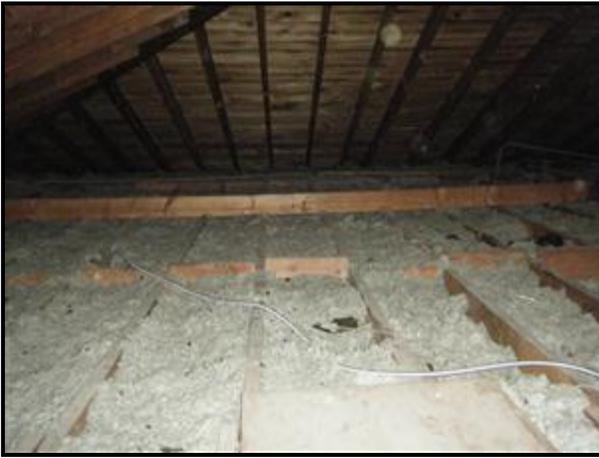
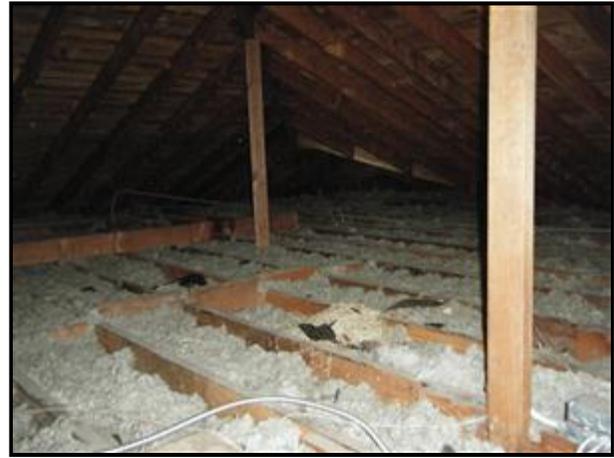
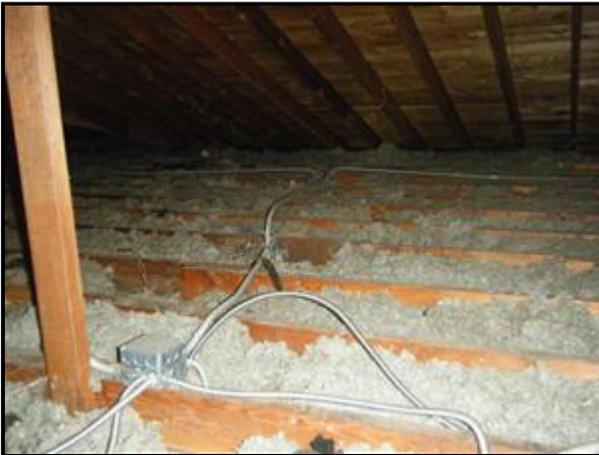
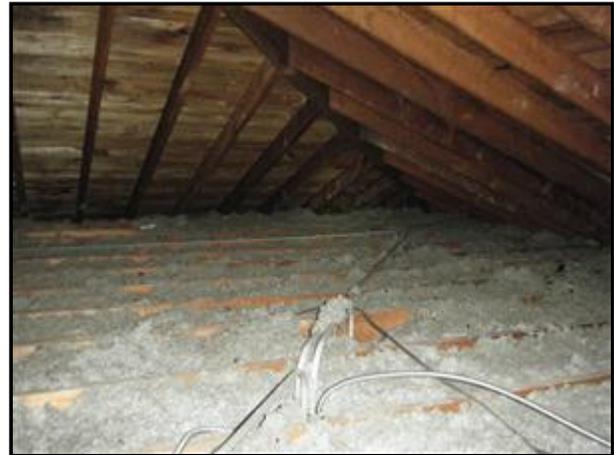
The high seasonal electric bills are largely the result of heat gain from the under ventilated and poorly insulated attic. Proper ventilation limits the heat gain of the attic during the day and allows the heat to dissipate more quickly at night. Increasing insulation to R-50+, using a non-air permeable insulation (cellulose or spray foam) will halt the transfer of heat from the attic to the conditioned space below.

Considering the front of the home faces West, integrating plantings and/or window shades will help limit the solar heat gain from the late day sun.

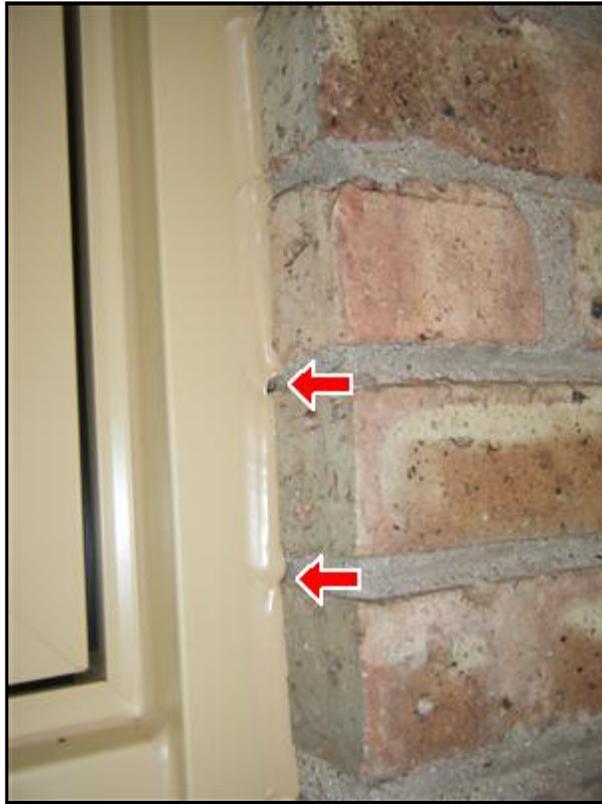
7.5 Picture 1

The new double pane windows have been installed well and show no sign of air leakage. There are a few minor gaps in the exterior caulk that should be filled to ensure no moisture enters the wall assembly.
