Inspection Report

Property Address:

115 E. Ogden
Naperville IL

Date: 1/1/2013	Time: 02:45 PM	Report ID: HI - 120521
Property: 115 E. Ogden Naperville IL	Customer: T. Smith	Real Estate Professional:

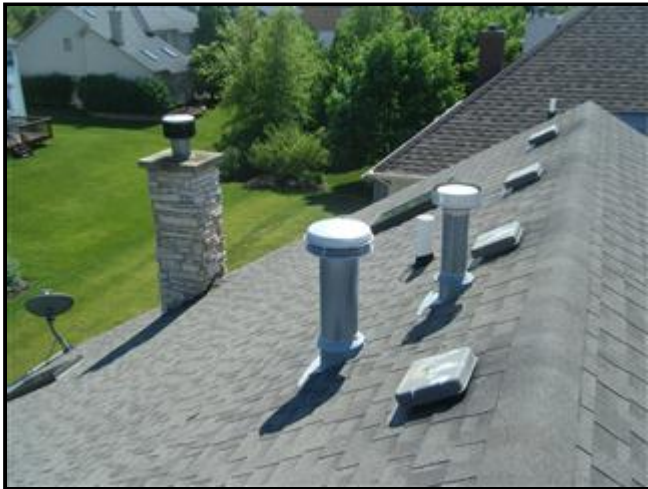
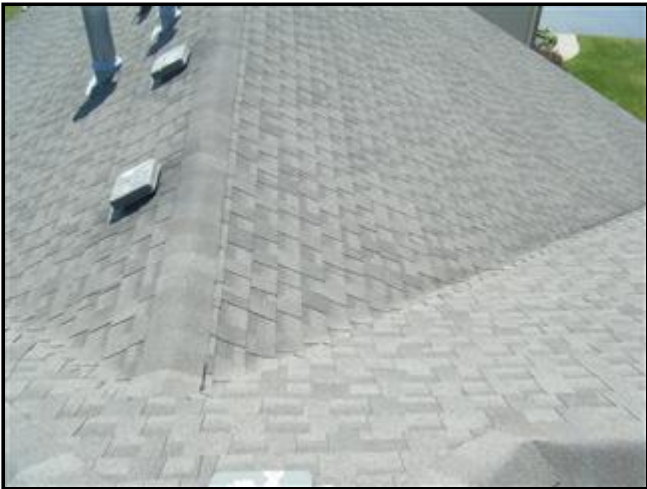
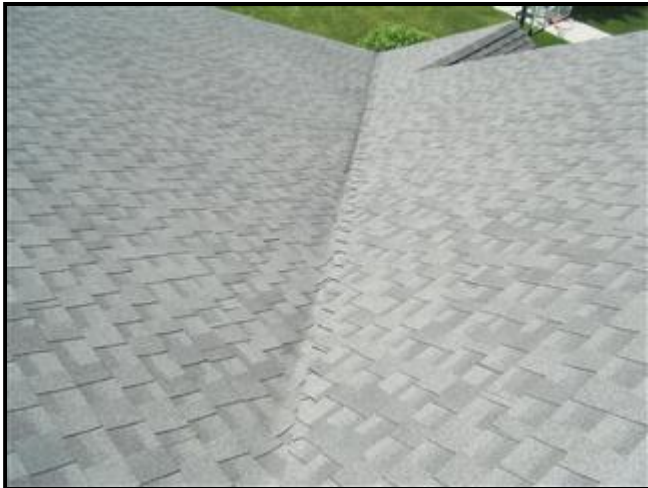
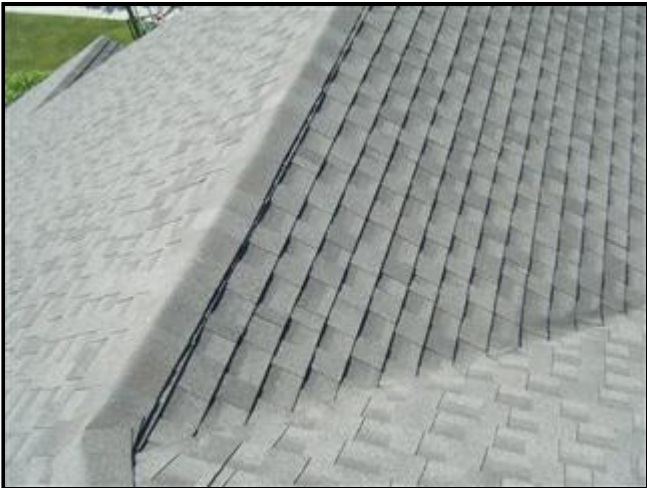
(1) The shingles are original to the home, ~11 years old and generally seem to be in fine condition.

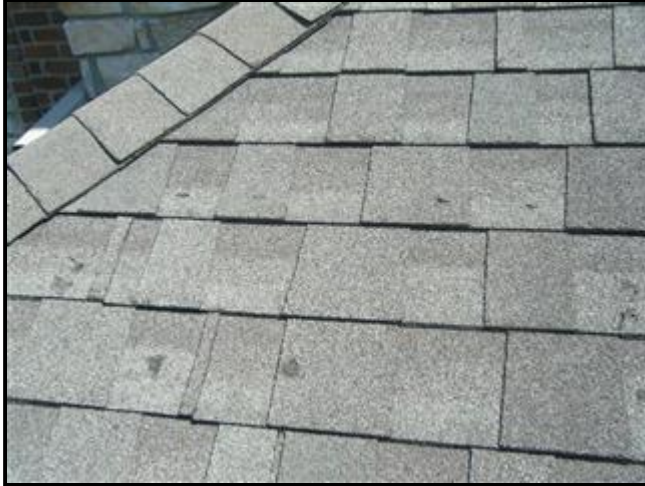
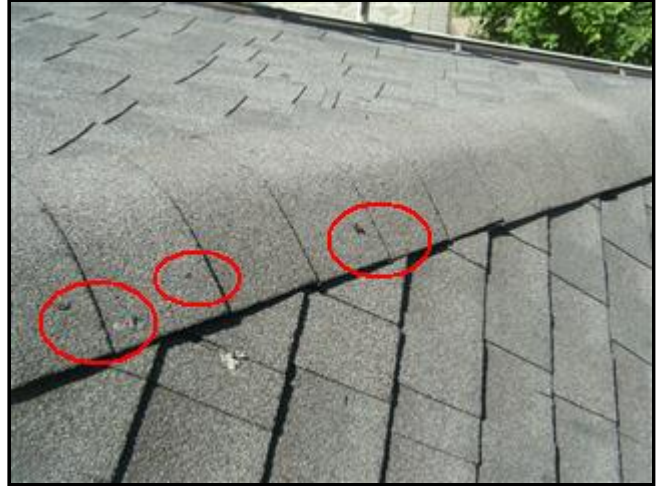
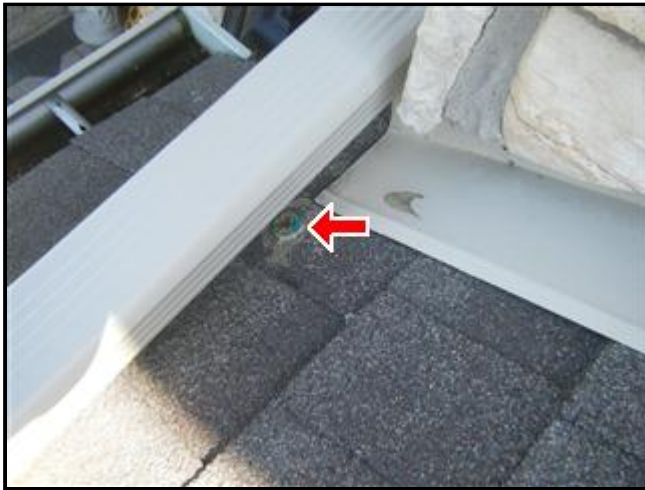
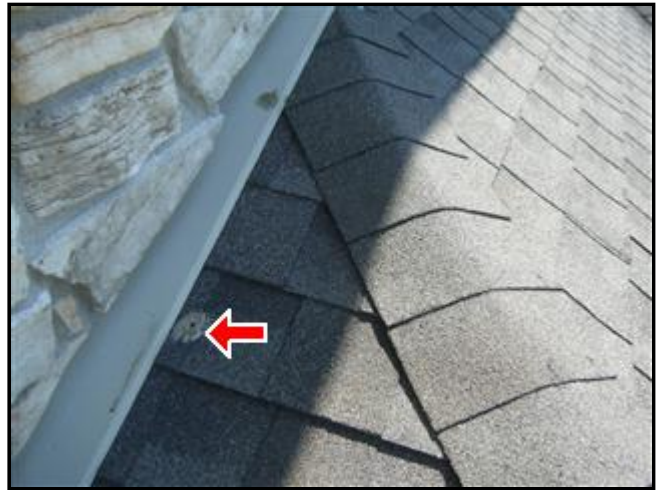
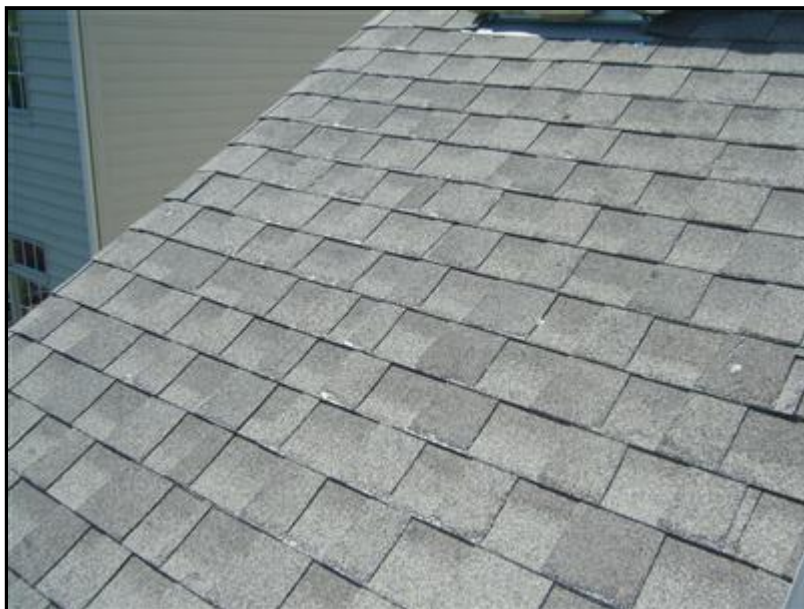
(2) There are a few areas of mechanical damage - scuffs, caulked holes, nail heads protruding, cap nails caulked, etc. None of these areas showed any signs of leakage underneath in the attic. Recommend the roof be inspected periodically.

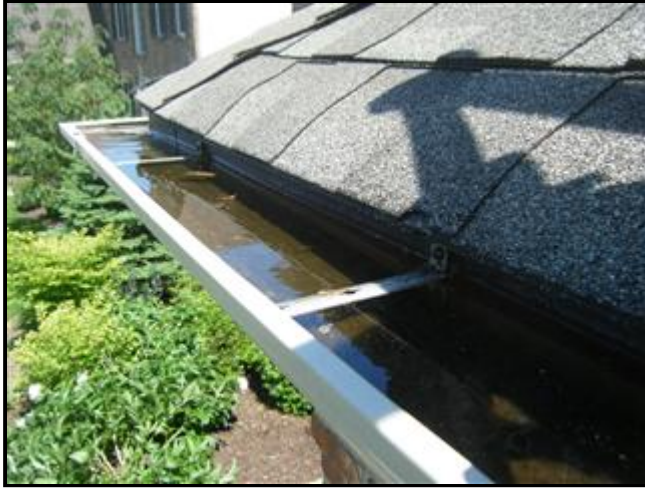
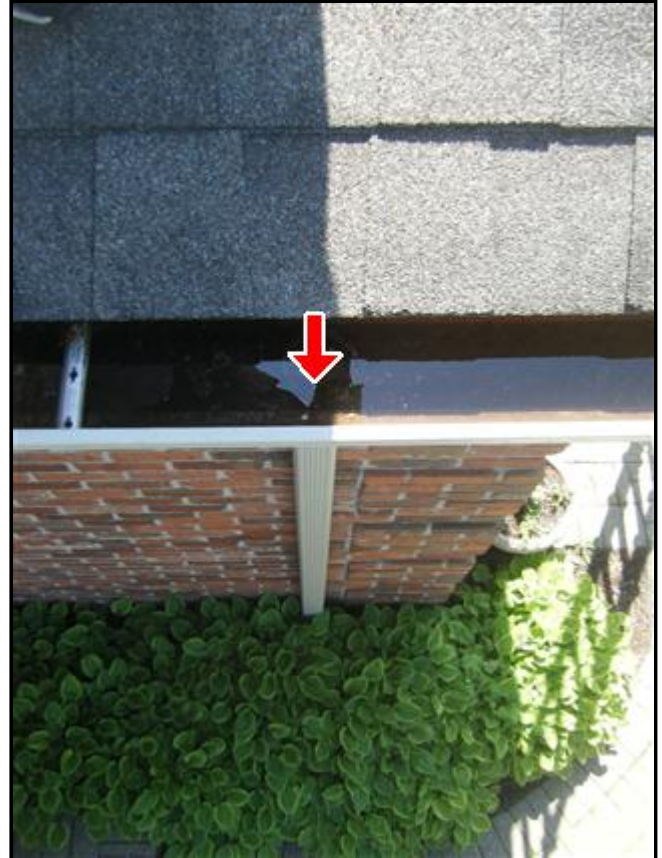
(1) The gutters are full of debris in areas and needs to be cleaned. Recommend cleaning the gutter at least twice per year or installing appropriate gutter guards

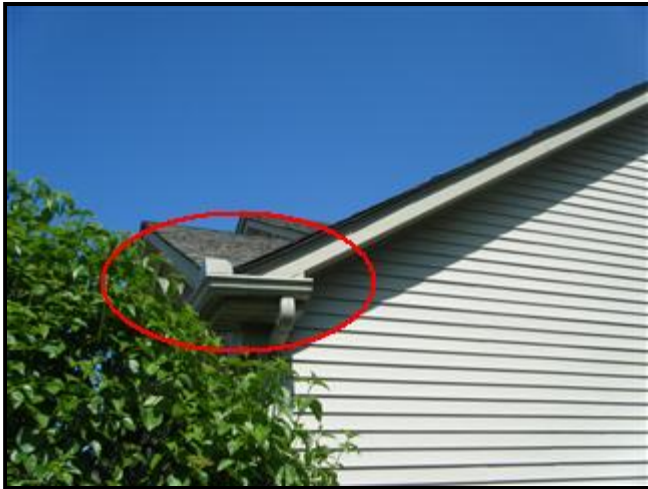
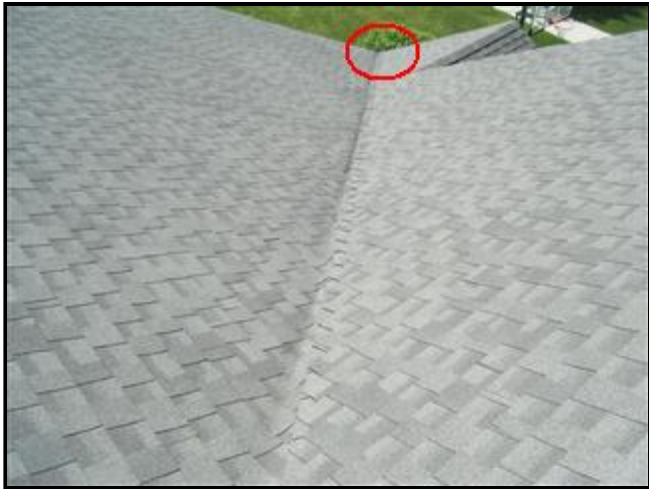
(2) The NW roof of the home drains to a small section of gutter and one downspout. Recommend this area be monitored during rains to determine if this configuration is handling the water well or if modifications are needed.

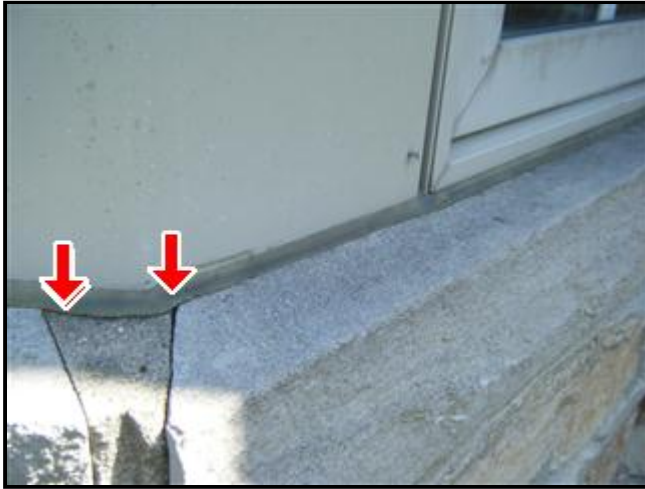
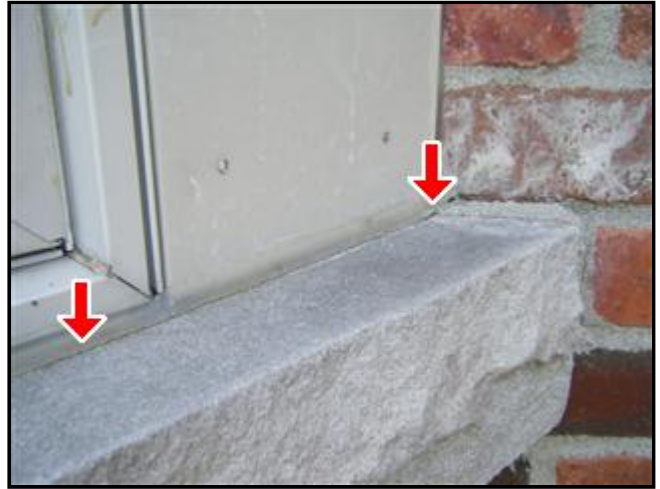
The clear sealant along the front windows is fractured along the stone sills and cladding. Recommend this caulk be removed and the windows re-sealed with a high quality, exterior grade sealant.

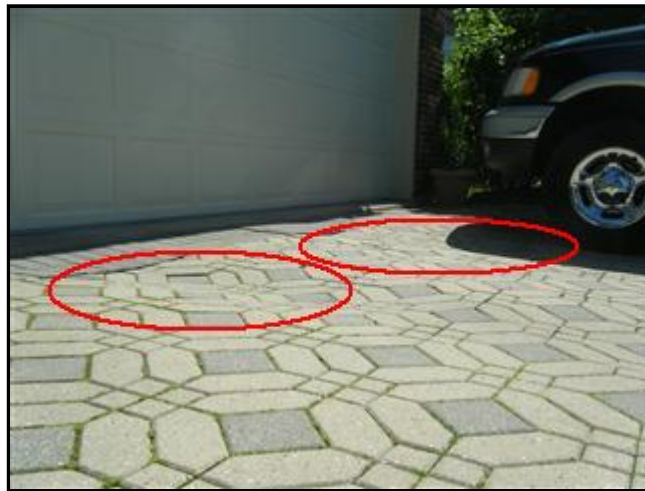
2.3 Picture 1

The paver drive has settled where the base was insufficient. Recommend limiting parking cars on the paver drive.

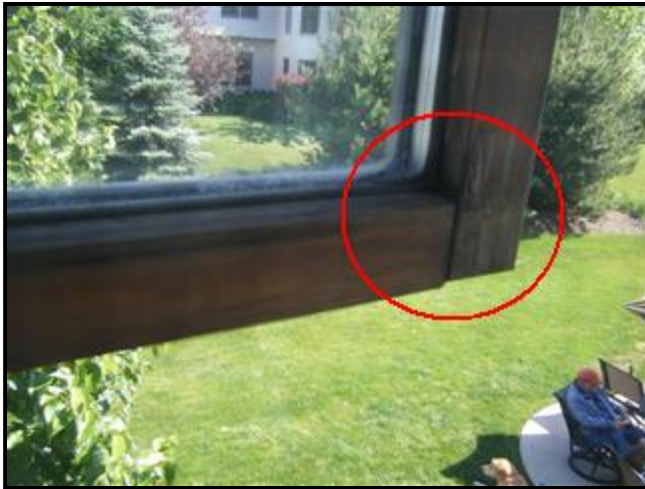
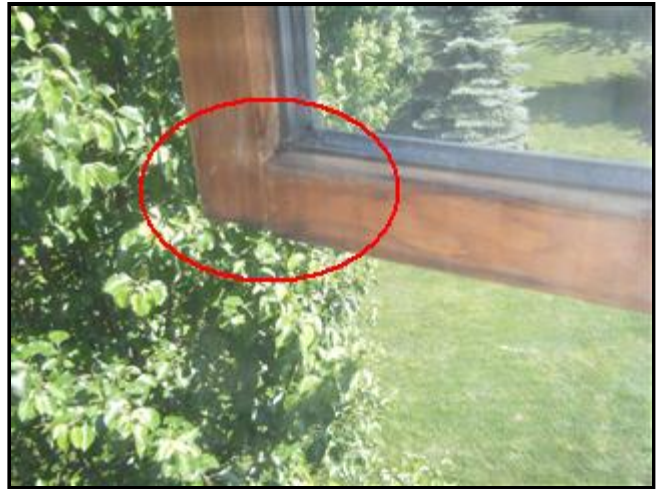
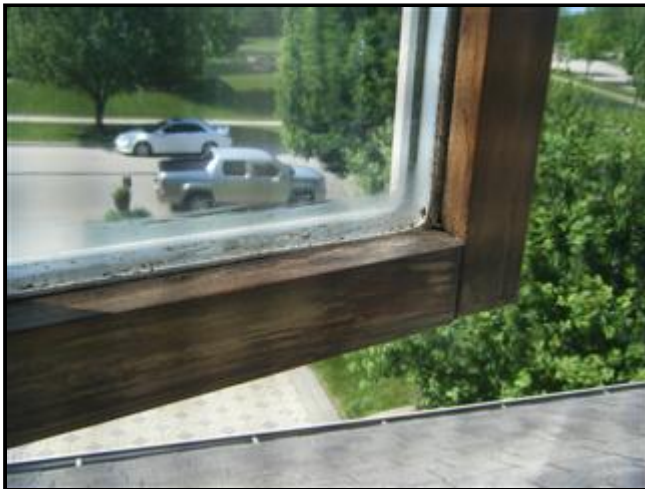
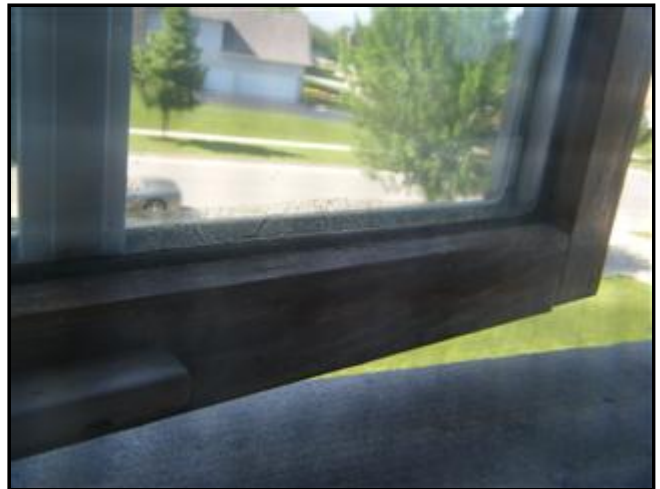
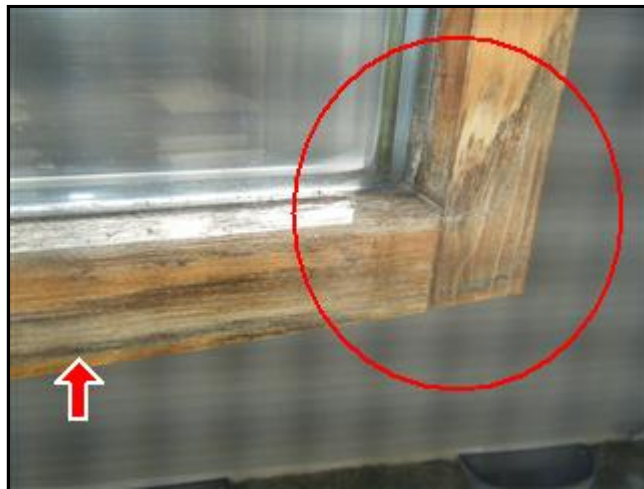
The windows are generally in good condition. There are signs of condensation and staining on the sashes. In fact, the bottom sash frame seems to be separating from the vertical. Recommend a qualified window repair specialist secure and refinish the sash frames to provide another 10+ years of function.

Note: Condensation can be limited by warming the surface (caulking gaps, adjusting blinds and curtains) and/or lowering the humidity in the home (turn down humidifier, use exhaust fans).

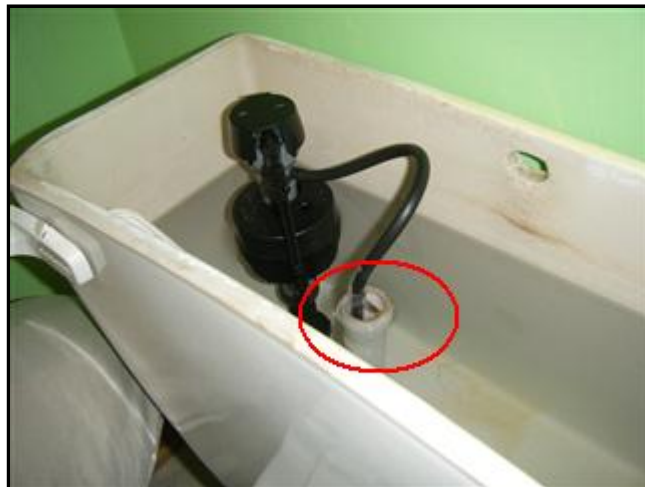
6.1 Picture 1

The toilet fill valve level is set too high, stopping at the top of the drain tube. This can easily lead to water being wasted, running down the drain. Recommend the fill valve be adjusted so the water level is ~1" below the tube.

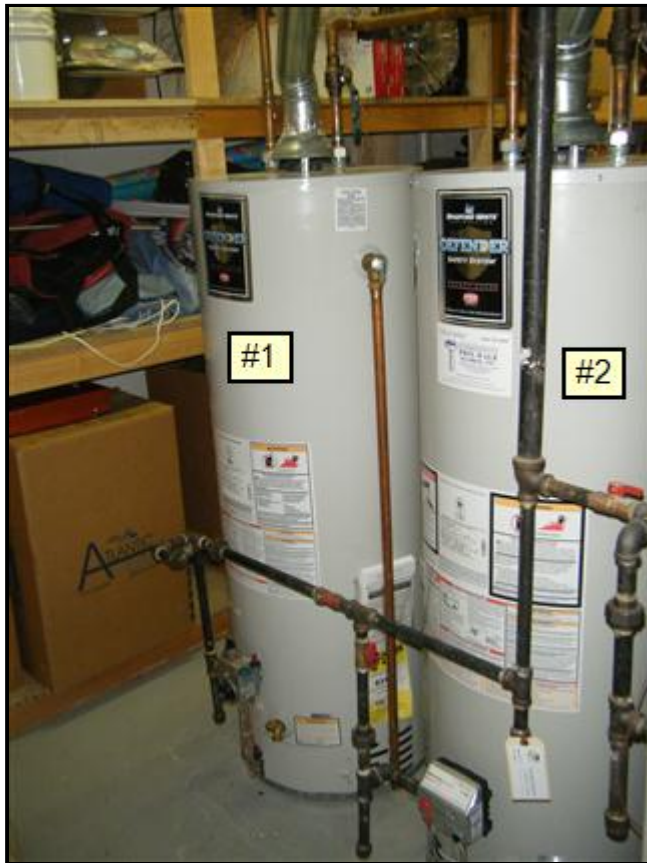
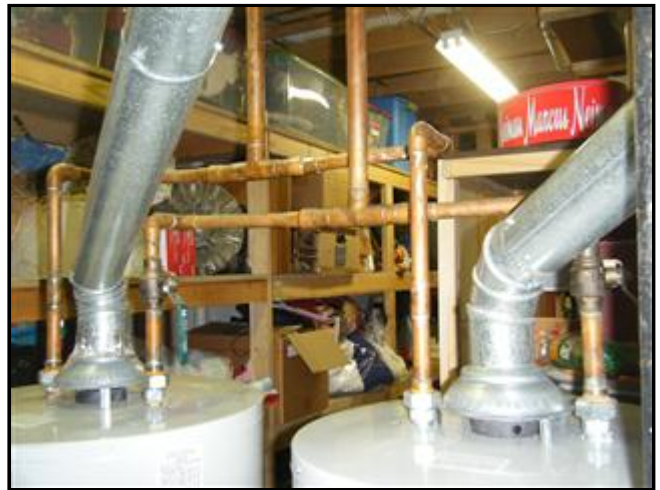
The water heaters are ~4years old and 3 months old, respectively, of their expected service life (10-15 years). Both units seem to be functioning well.

Should one of the units fail over time, recommend the units be *upgraded* to a high efficiency power vented or sealed combustion unit, either tanked or tankless. In addition to being more efficient, either type will eliminate the risk of exhaust gas spillage that exists with the current natural draft units.

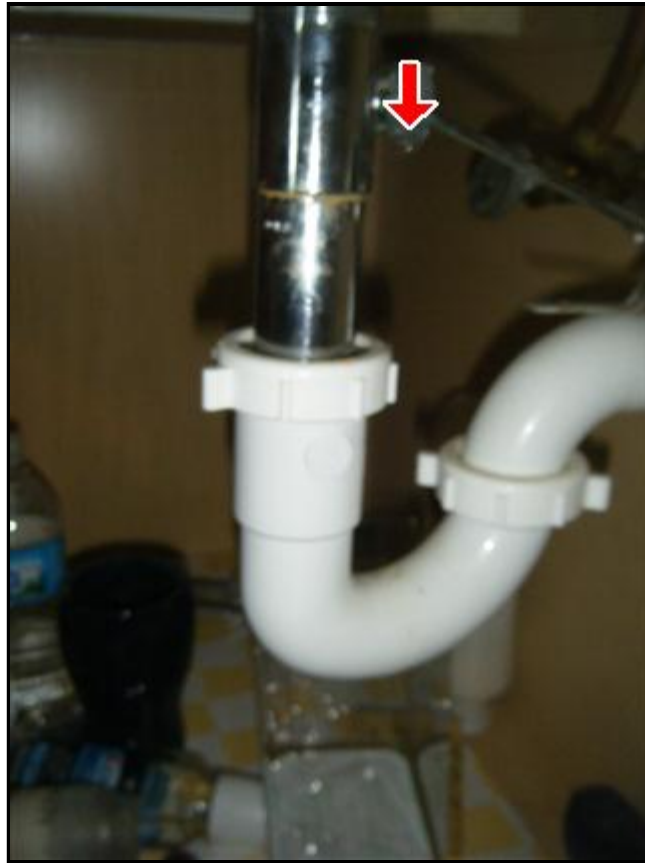
6.3 Picture 1

(1) The pop-up stopper assembly is leaking below the lavatory to the right (west) of the shared bathroom.

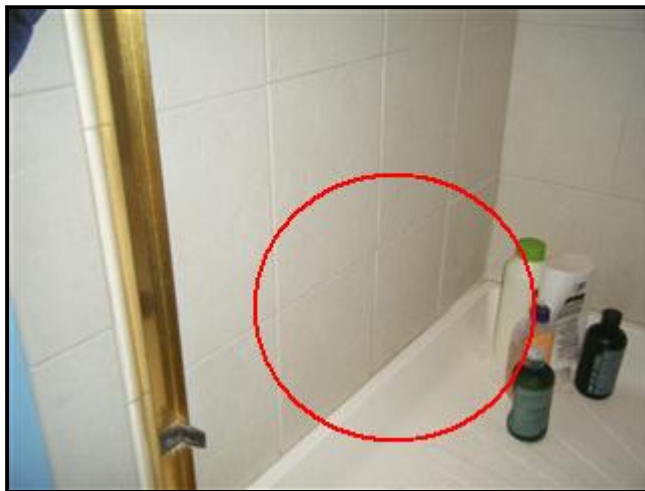
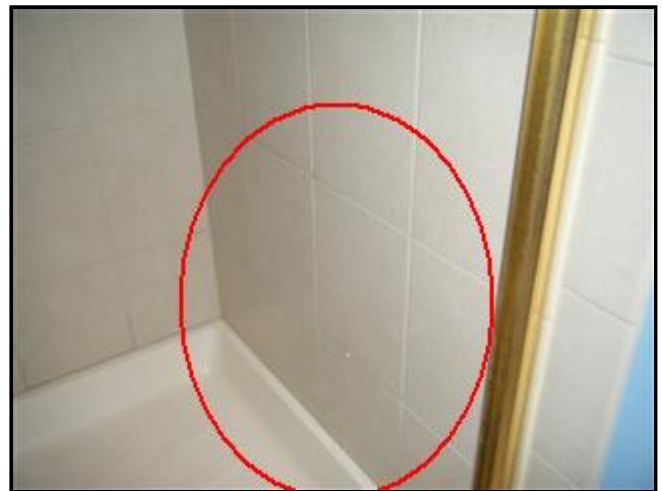
(2) The shared shower has tiles that have de-laminated from the wall board from water entering at the cracked grout lines. Recommend a qualified individual reset the tiles, re-grout all and re-seal the corners.

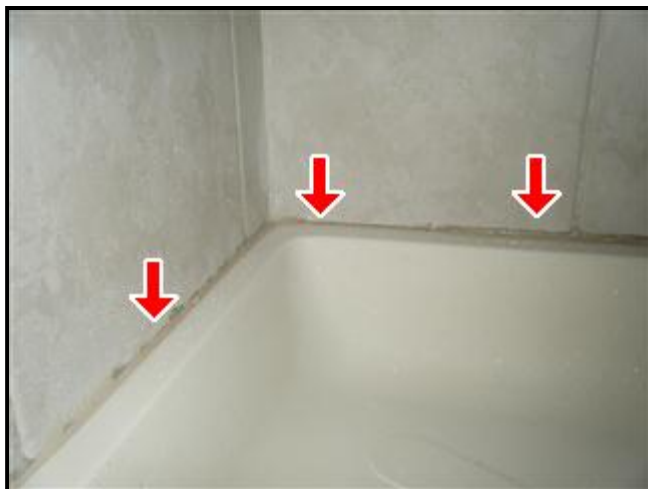
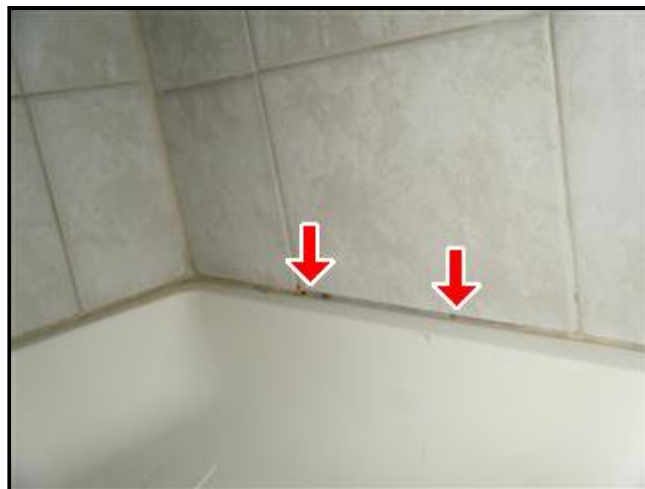
(3) The bottom caulk line of the master shower stall is fractured and starting to mildew. Recommend the caulk be removed and the joint resealed with a high quality, anti-microbial sealant.

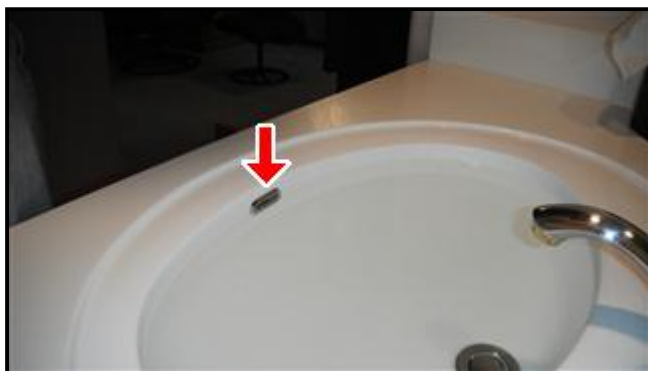
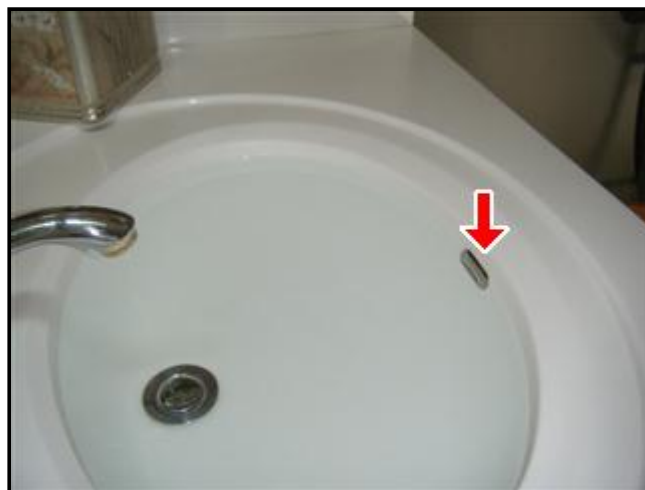
(4) Most of the lavatory over flow drains are clogged and offer no over flow protection. Recommend the drains be cleared.

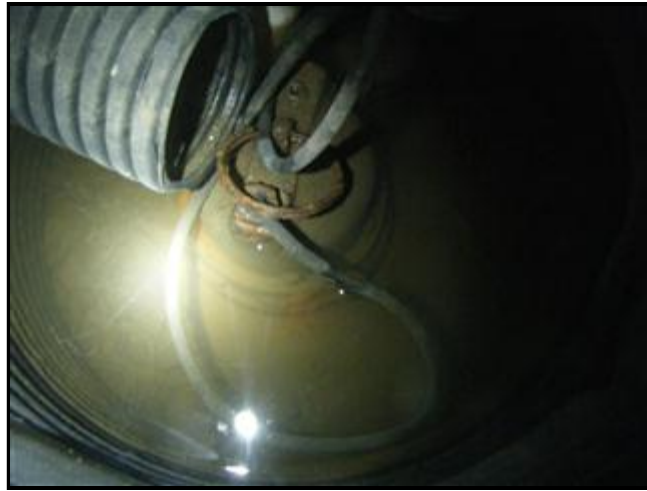
6.4 Picture 1

(1) The storm water sump pump is located in the closet along the east wall of the basement near the water meter. The pump turned ON when plugged in directly, although little water was pumped from the pit (the check valve may be stuck). It was not determined if the attached pressure switch is functioning. The sealed cover did not allow for closer inspection. Recommend the unit be checked for proper function.

Recommend a high water alarm be installed in the pit to alert to a pump failure before water backs up the drain onto the floor. For additional protection, recommend a battery back-up pump be installed in case of power outage or primary pump failure.

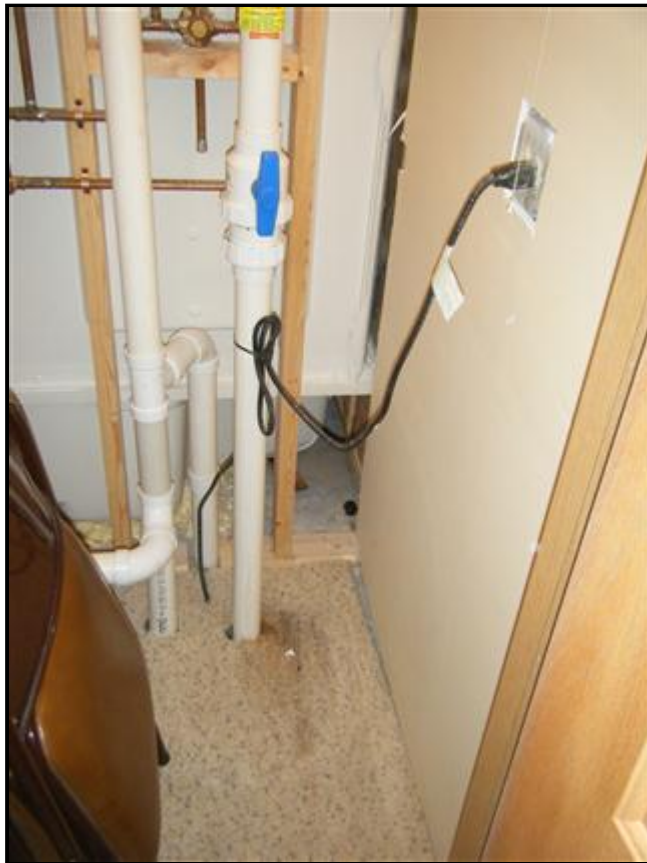
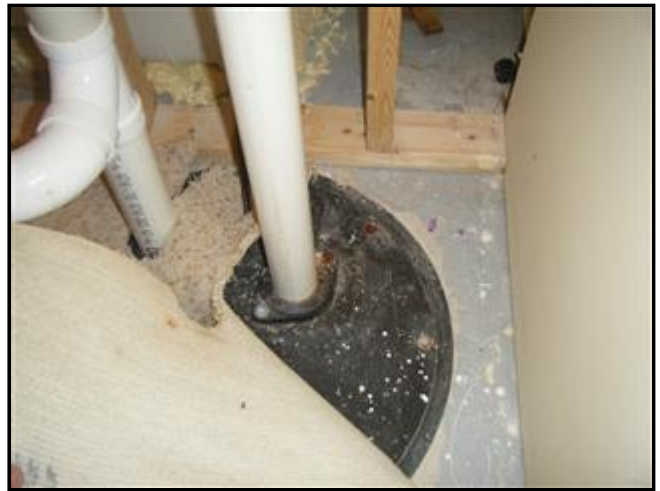
(2) The sewage ejector pit collects water from the basement bathroom and floor drains. The pump is sealed. Water was run in the bathroom and the pump turned ON. Recommend a high water alarm be installed in the pit to alert to a pump failure before water backs up the drain onto the floor.

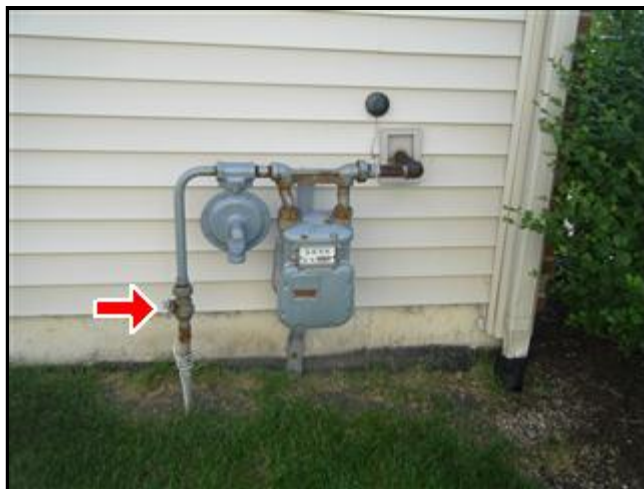
6.5 Picture 1

The main fuel shut off is at gas meter outside along the east wall at the NE corner.

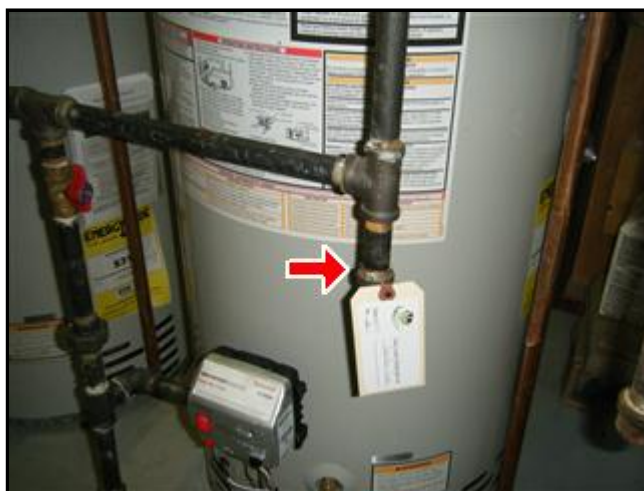
6.6 Picture 1

A gas leak was located at the drip cap near water heater #2. Recommend a qualified individual repair and retest the gas pipes for leaks.

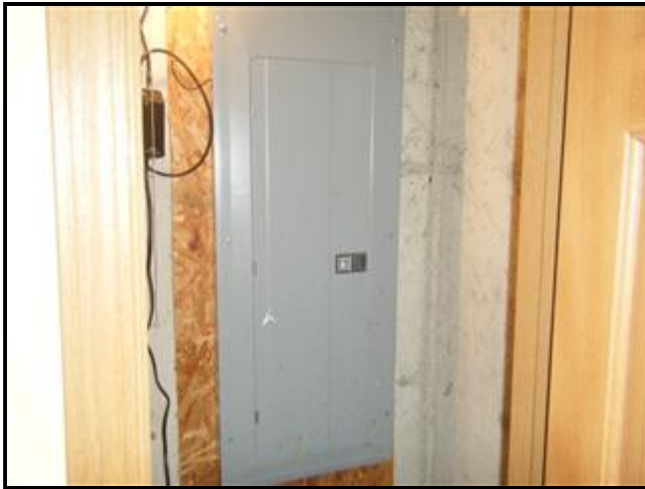
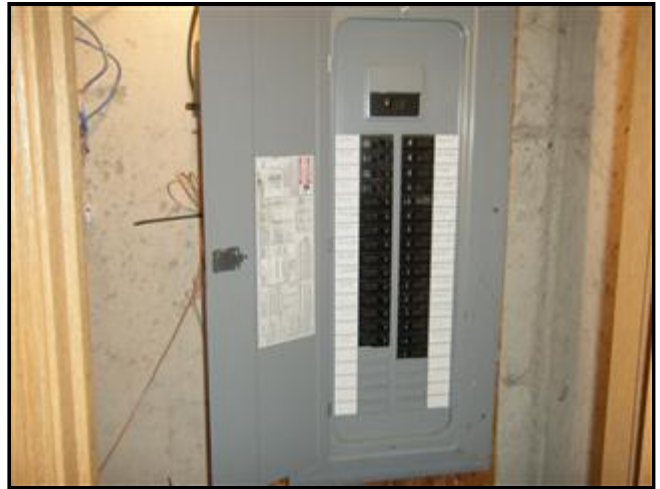
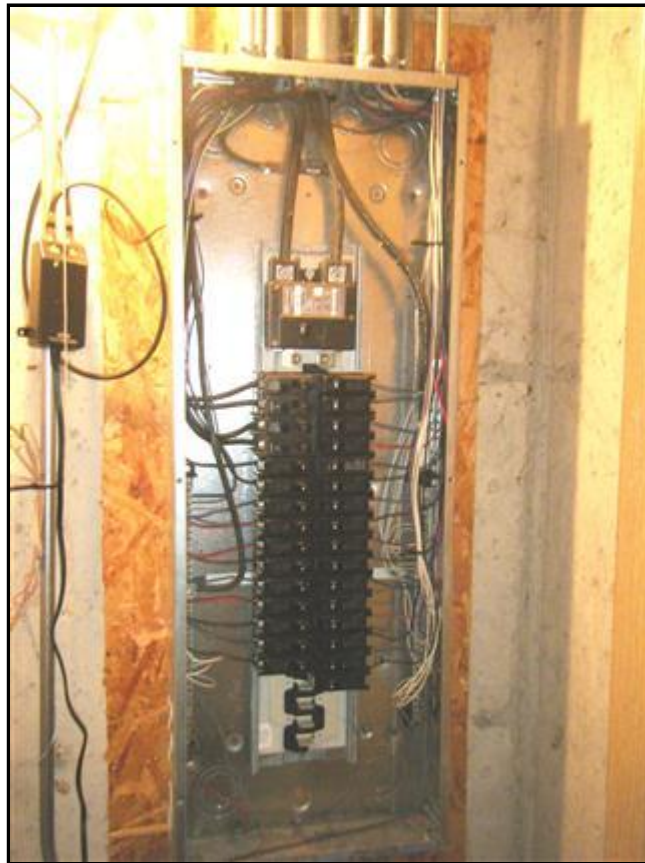
- (1) The main electrical panel and disconnect are located in the SW corner of the basement.

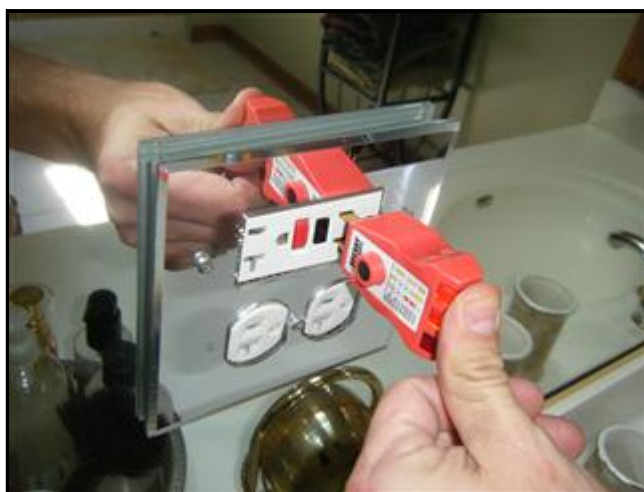
The outlet in the master bath is loose. Recommend a qualified individual secure the devices to the electrical box behind and replace the mirrored wall plate.

7.4 Picture 1 Loose

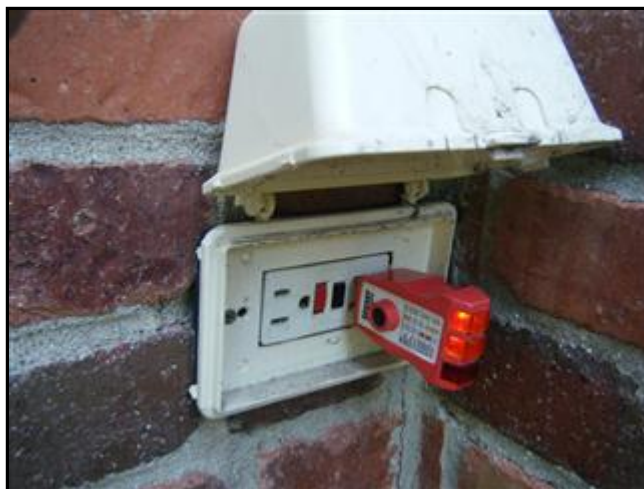
7.6 Picture 1

The GFCI outlet did not trip with a simulated ground fault . Recommend a qualified electrician repair or replace the device as necessary.

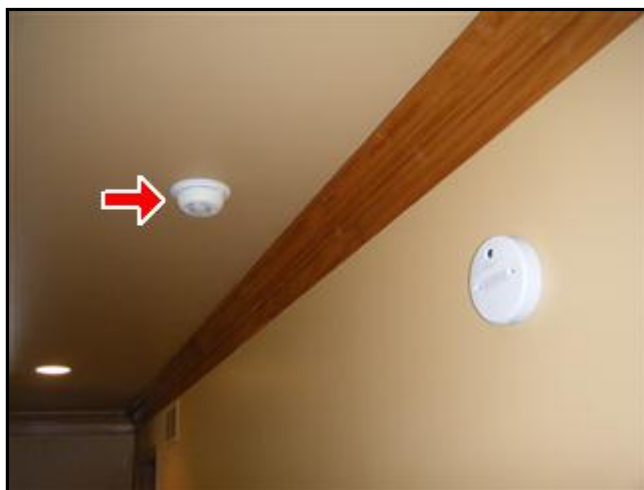
7.7 Picture 1

The average service life of a smoke detector is 10 yrs. Be sure to replace batteries yearly and replace the units entirely after 10 years. Recommend one smoke detector per floor and one within 15 feet of the bedrooms.

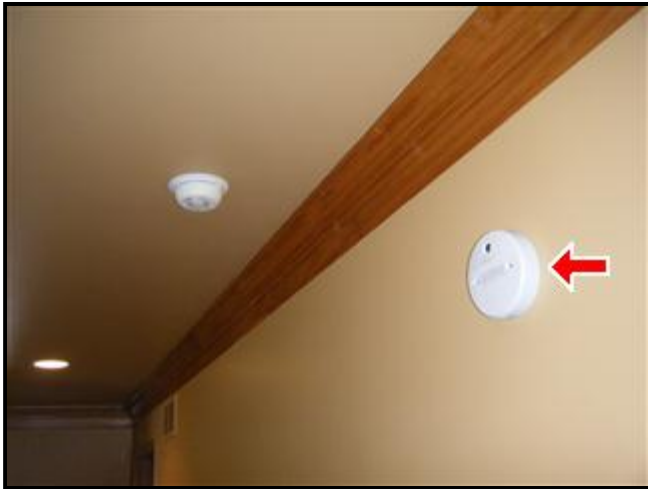
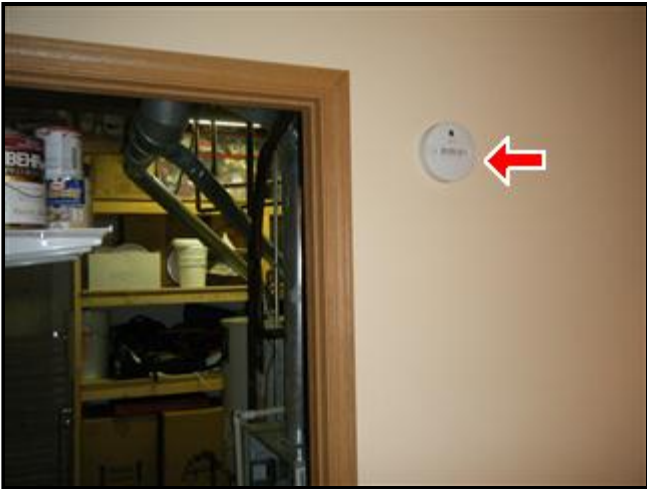
The average service life of a carbon monoxide detector is 2-3 yrs. Be sure to replace batteries yearly and replace the units entirely after 3 years. Recommend one CO detector near each CO source (water heater / furnace, kitchen, door to garage, etc) and one within 15 feet of the bedrooms.

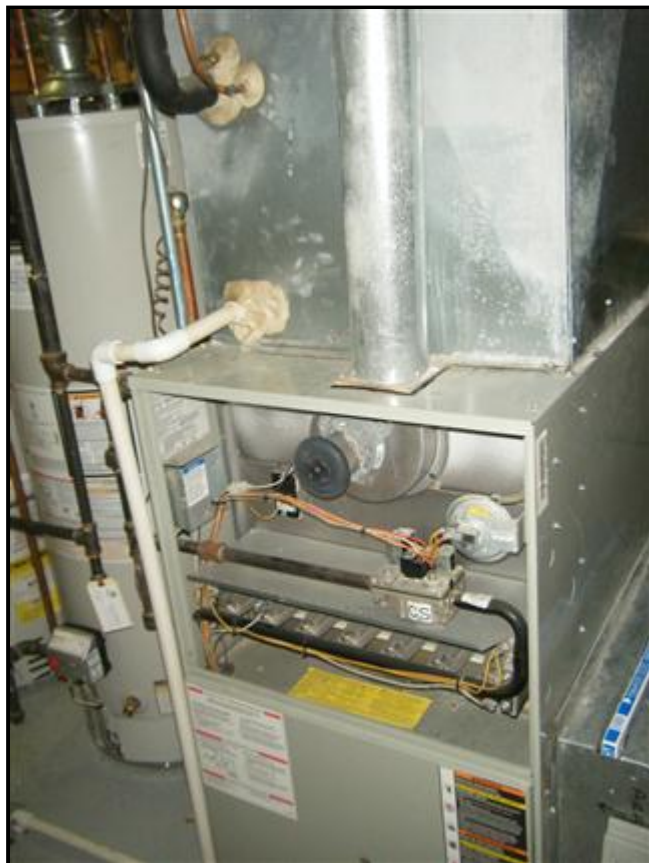
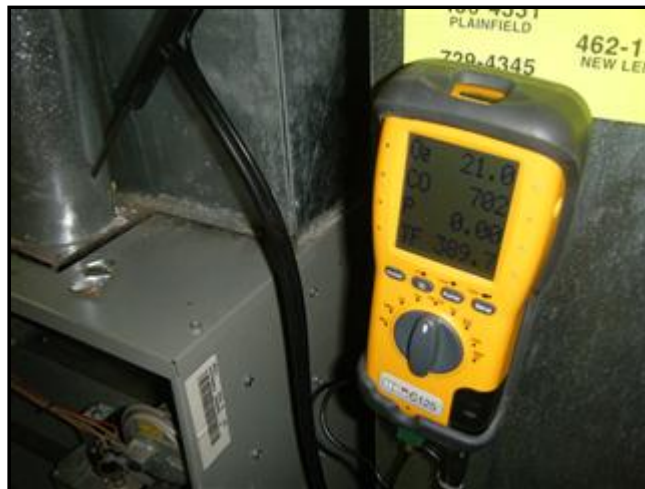
The furnace is about 11 years into an expected service life of 25 years and seems to be in fine condition. Recommend the unit be cleaned and/or serviced twice a year to prolong its service life. Filter should be changed monthly or as needed.

The furnace tested high for CO output, 700+ppm at steady state operation. Ideal CO output should be 25 ppm or less. Recommend a qualified HVAC technician determine the cause of the high CO and repair as needed.

8.0 Picture 2 CO - 702 ppm at Steady State

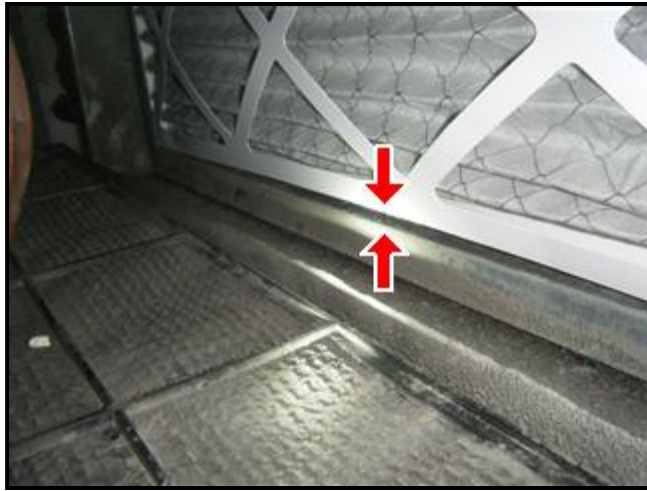
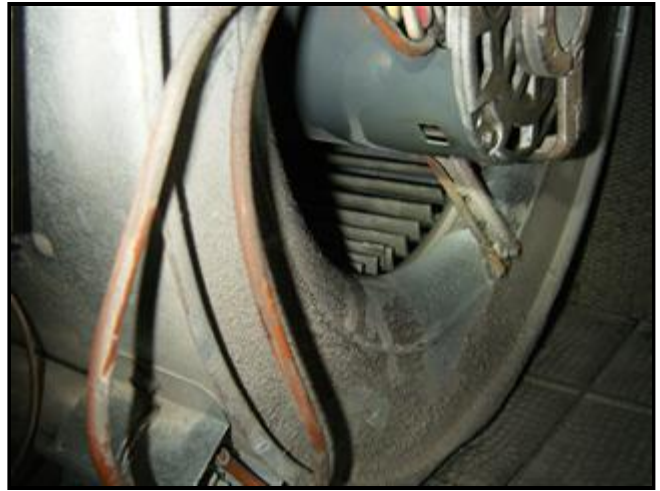
The filter fits poorly in its slot, allowing air and debris to flow around and collect on the ducts, blower and likely the AC coil above. Recommend the air handler be cleaned and the filter rack be adjusted so the filter can seal as the fan draws air through it.

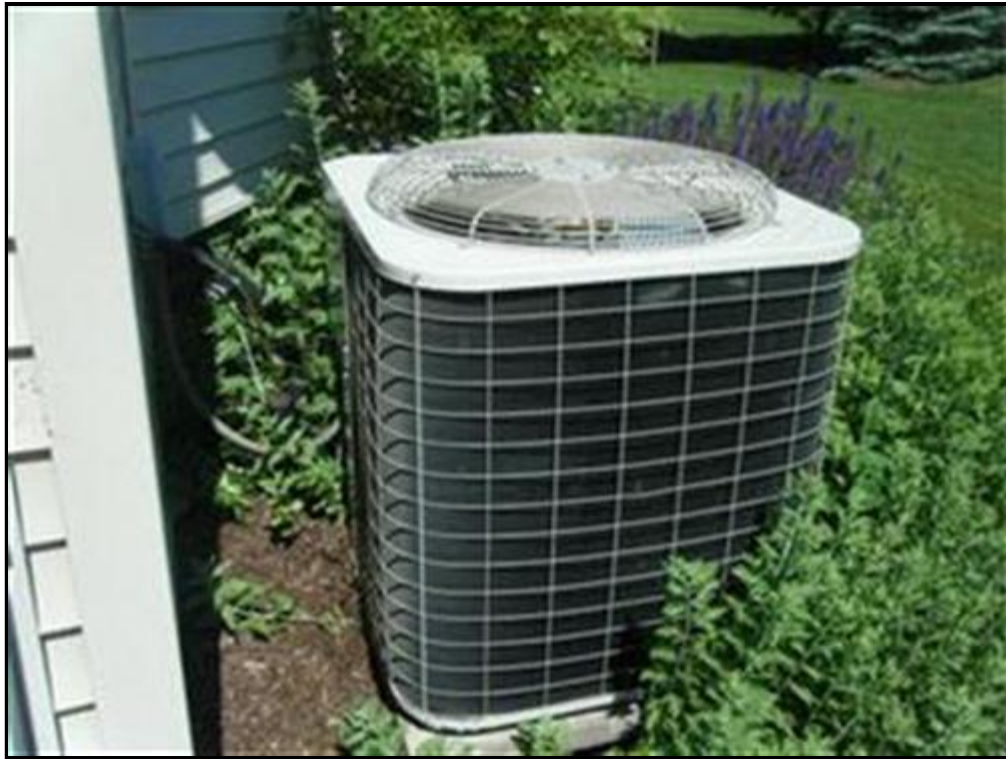
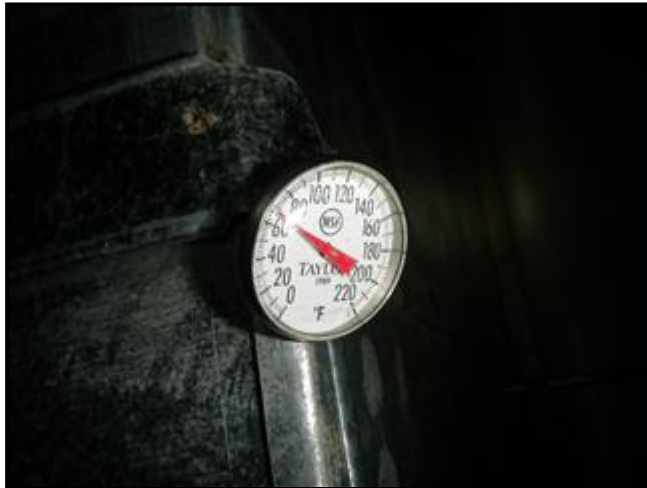
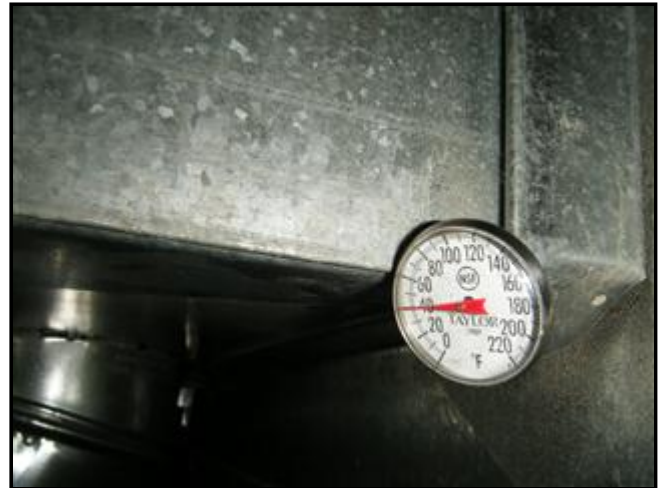
(1) The AC is about 11 years into an expected service life of 20 years and seems to be in fine condition. Recommend the unit be cleaned and/or serviced once a year to prolong its service life. Lint, debris and vegetation should be kept clear, 1' of the sides of the unit to ensure proper air flow and efficient function.

8.6 Picture 2 68 degree Air In

8.6 Picture 3 40 degree Air Out

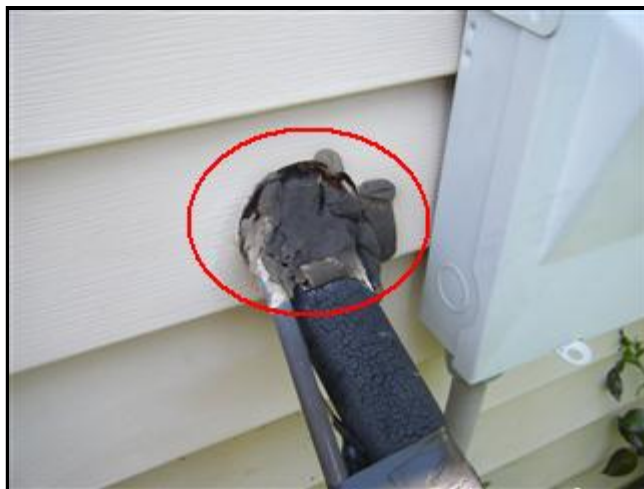
8.6 Picture 4

(2) The hole through the siding should be re-sealed to keep moisture and pests out of the wall assembly.

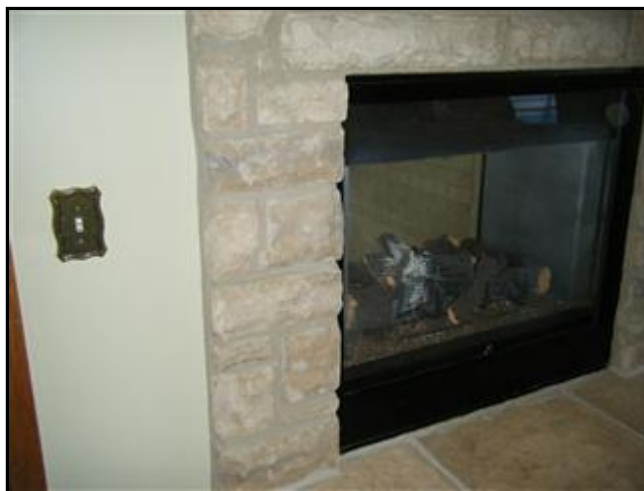
8.9 Picture 1

(2) The master suite fireplace turns ON with the 'light switch' to the left. Recommend a qualified chimney sweep inspect the unit and instruct the new homeowner in the safe & proper operation of the fireplace.

(1) Before the fireplace is used, a qualified chimney sweep should clean the chimney flue, lubricate the flue damper to ensure smooth & safe function and instruct the new homeowner in the safe & proper operation of the fireplace.

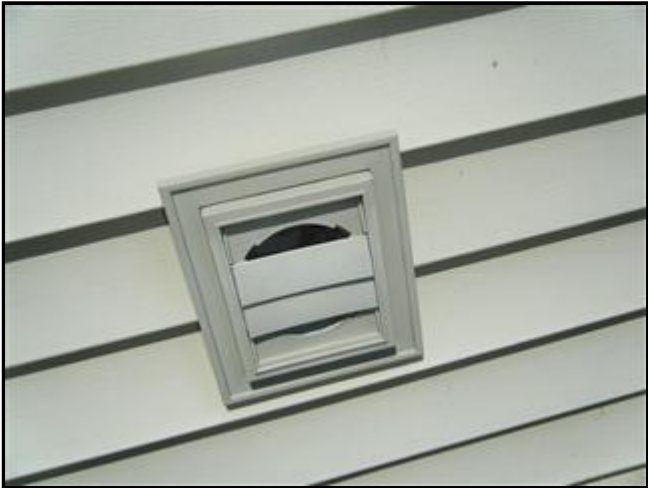
(1) Recommend the vent flaps be replaced on the exhaust on the east side of the home to keep out pests and moisture.

9.4 Picture 1 Vent flaps missing

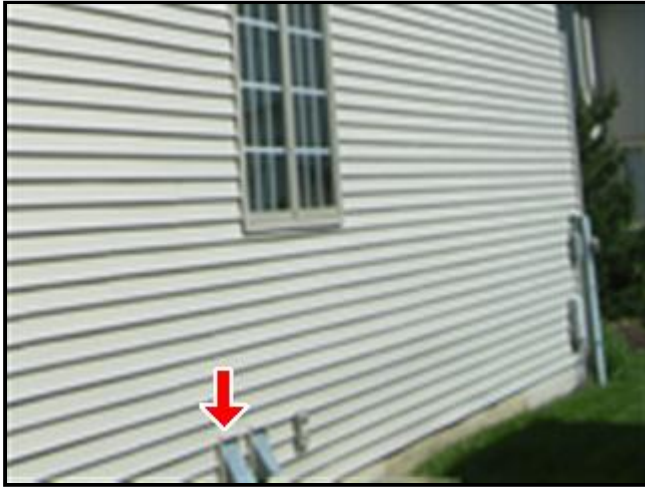
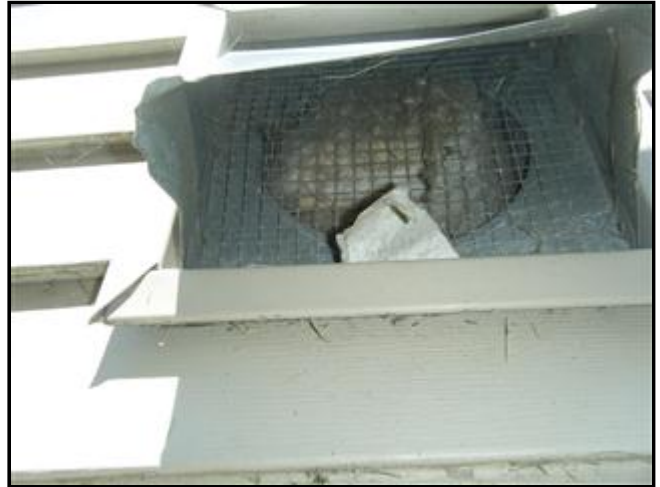
(2) There is an intake vent hood on the east side of the home that is blocked closed with insulation. It is not clear what this vent is for. Recommend consulting the homeowner regarding this.

9.4 Picture 3 Intake vent packed with insulation
