Inspection Report

Property Address:

115 E. Ogden
Naperville IL

Date: 1/1/2013	Time: 02:45 PM	Report ID: HI - 120521
Property: 115 E. Ogden Naperville IL	Customer: T. Smith	Real Estate Professional:

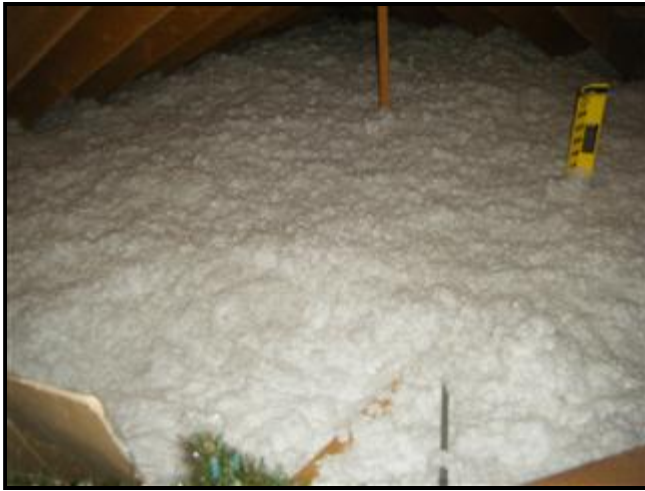
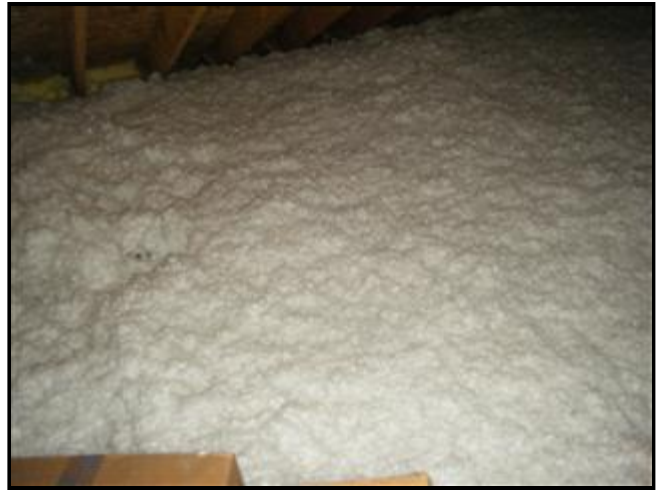
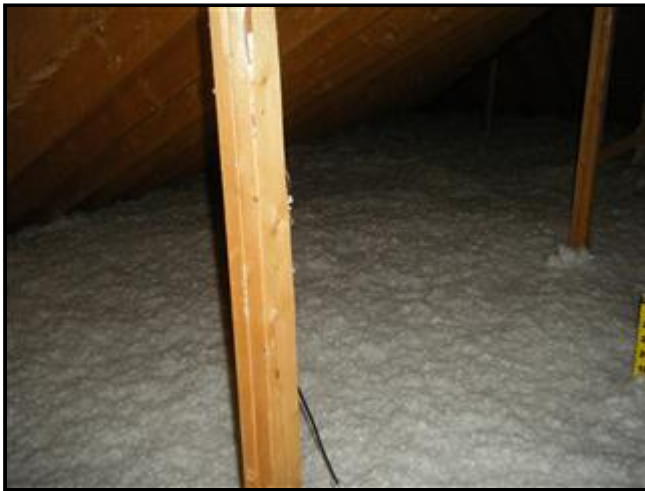
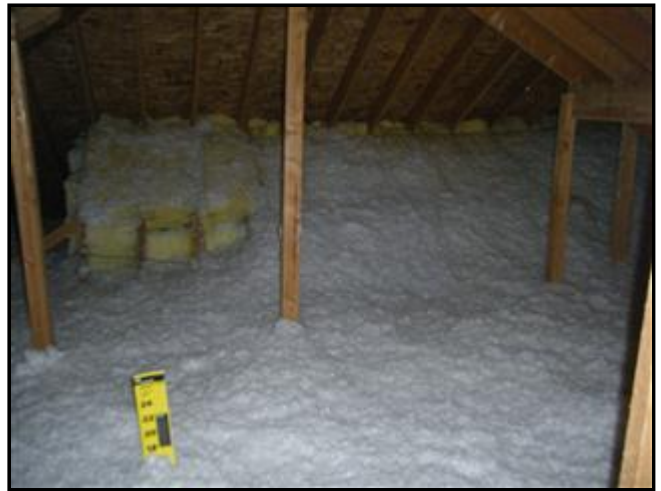
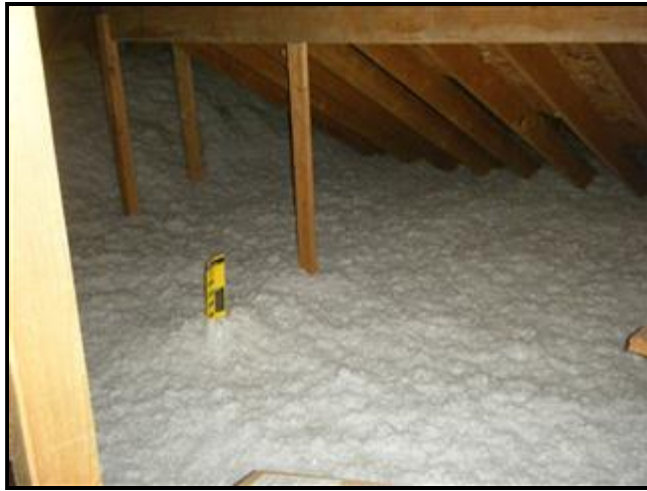
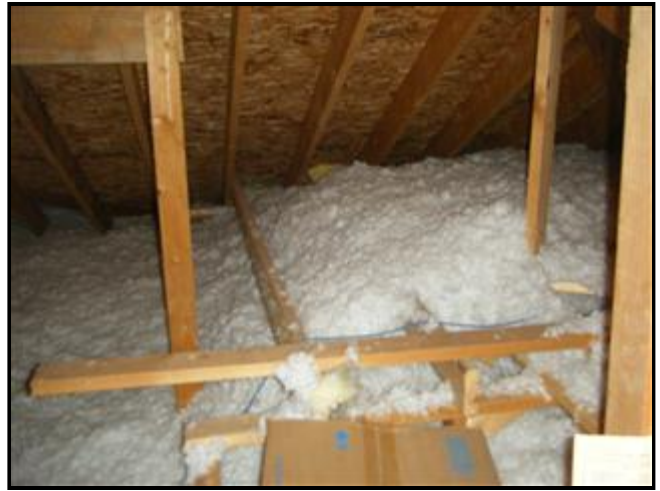
(1) The attic currently has ~R - 25-30 of blown fiberglass insulation, below the current code minimum of R-38. Recommend the attic be insulated to a more cost effective R-50/60 with blown cellulose (settles to an air-impermeable mass-unlike fiber glass), only after air sealing and attic ventilation issues have been completed.

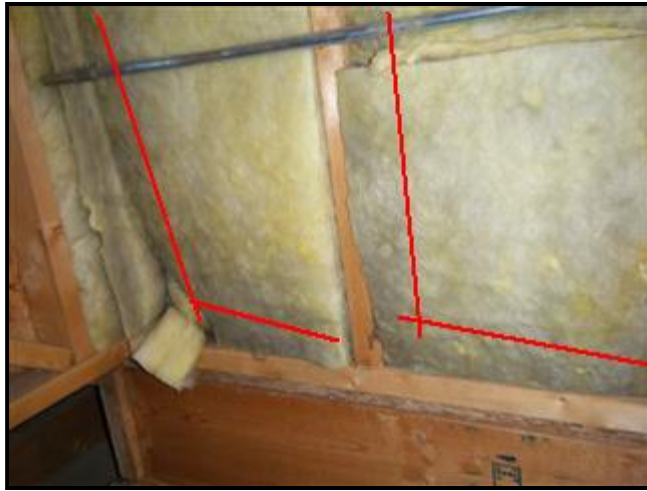
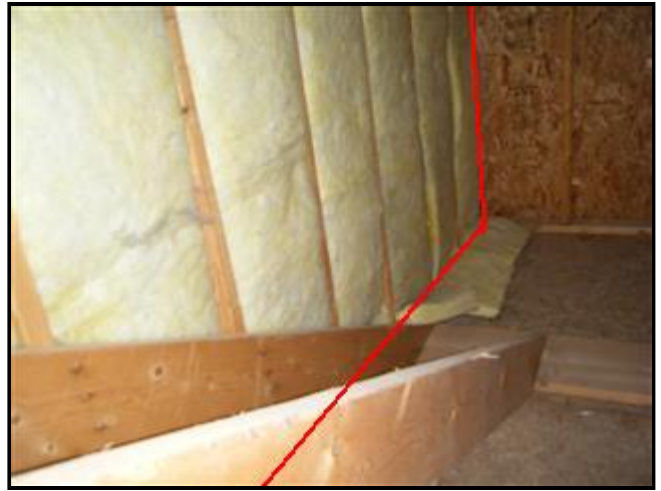
Parts of the north & west walls are exposed below the garage roof. The open fiber glass insulation allows air to flow into the wall through the insulation. Recommend a qualified air sealing & insulating contractor add Thermax-type foam board, sealing all seams and perimeter (down to the ceiling below) to create an air tight assembly. Ventilation along the roof sheathing should be maintained.

9.6 Picture 1 Fiber glass filtering air flowing in toward the wall
