Home Performance Report

115 E. Ogden
Naperville IL

Insight Property Services, Inc

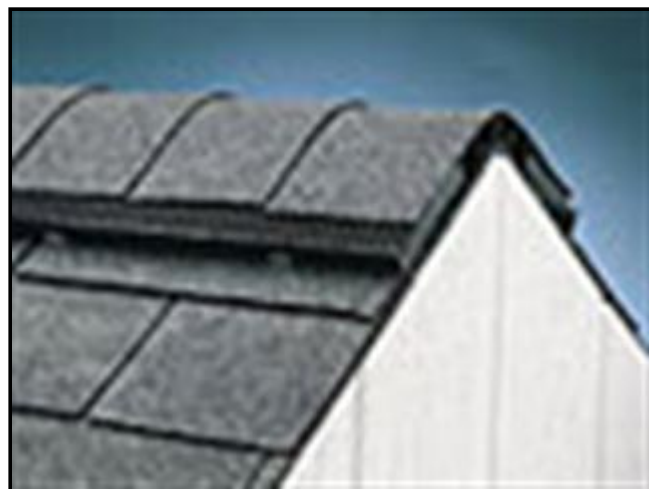
2.4 Picture 2 ShingleVent II

The top of the roof should also have 4 ft² of net-free exhaust opening. The existing (5) roof vents have ~140 in², about 25% of the necessary 576 in². [Air Vent's ShingleVent II](#) provides 18 in² net-free per foot while deflecting driving wind, rain and snow. The existing roof vents may remain and can be eliminated when the shingles are next replaced.
